Draft Phase II Environmental Site Assessment

Homes on the Range 902 3rd Street East, Roundup, Montana

Superfund Technical Assessment and Response Team (START) V Contract
Contract No. 68HE0820D0001, Technical Direction No. 2360-2311-03
Document Tracking Number (DTN): 1464

February 29, 2024

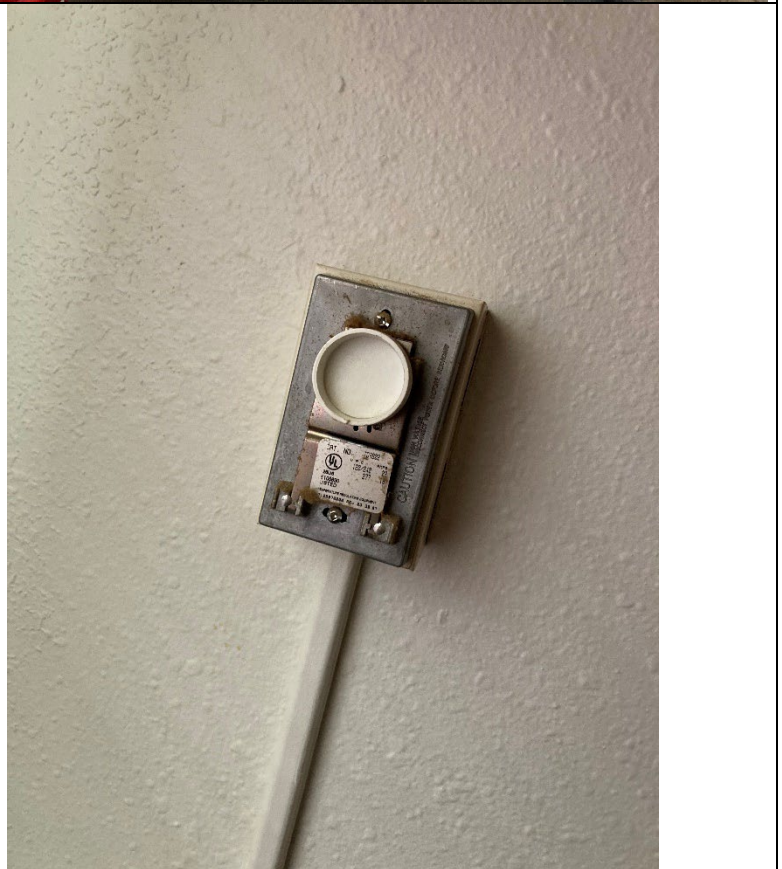
| Description: | Representative photo of suspected mercury-containing switch. |
