# ASBESTOS INSPECTION REPORT FOR MSU INNOVATION CAMPUS – NELSON DAIRY

NELSON DAIRY CENTER  
Bozeman, Montana

DATE OF INSPECTION: 09/19/18

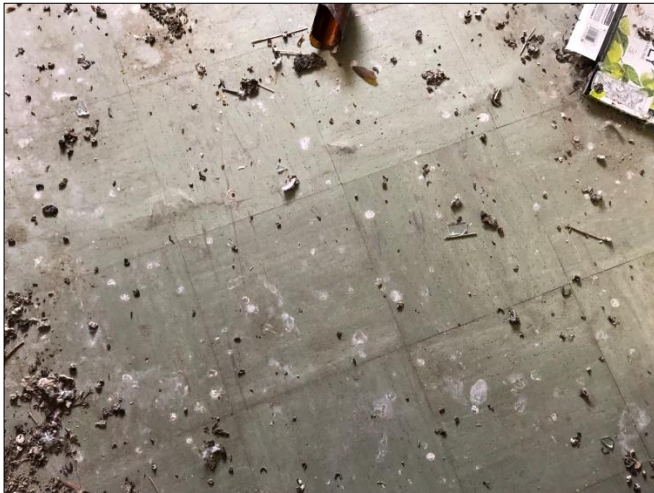
**9x9 Floor Tile & Mastic**

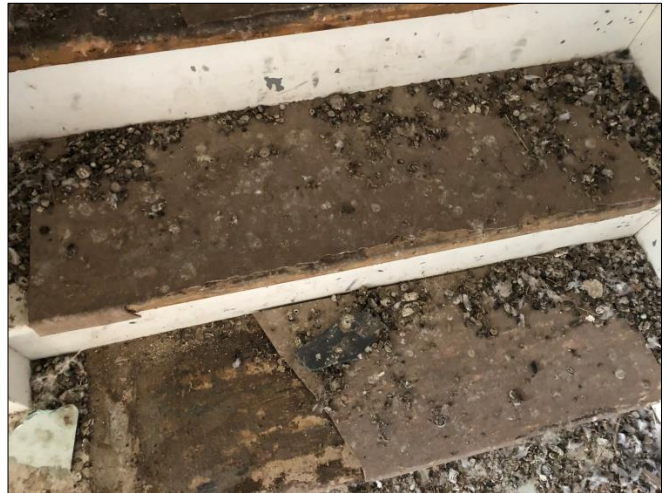
**Stair Tread Material**

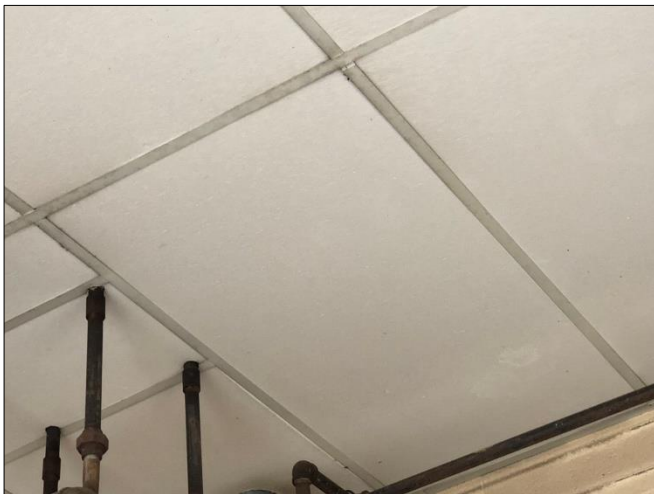
**2x4 Ceiling Tiles**

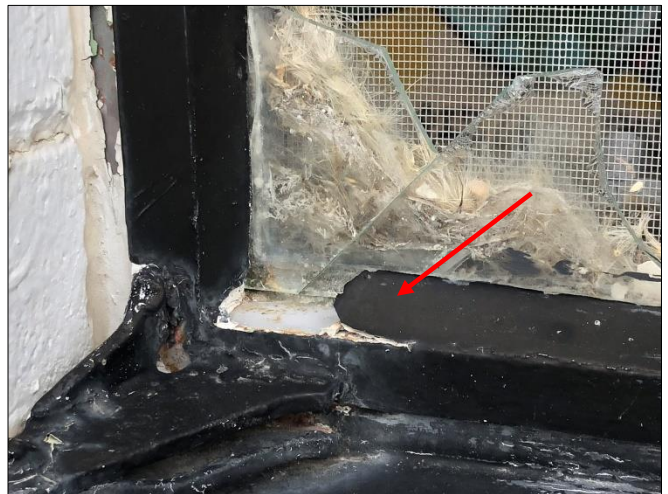
**Exterior Window Glazing**

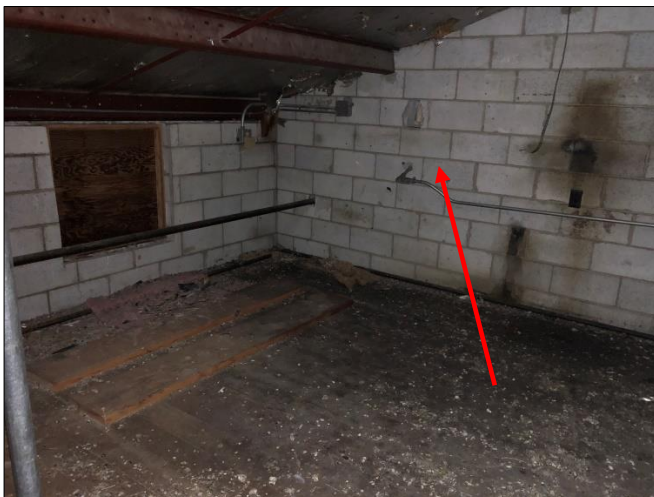
**CMU & CMU Mortar**

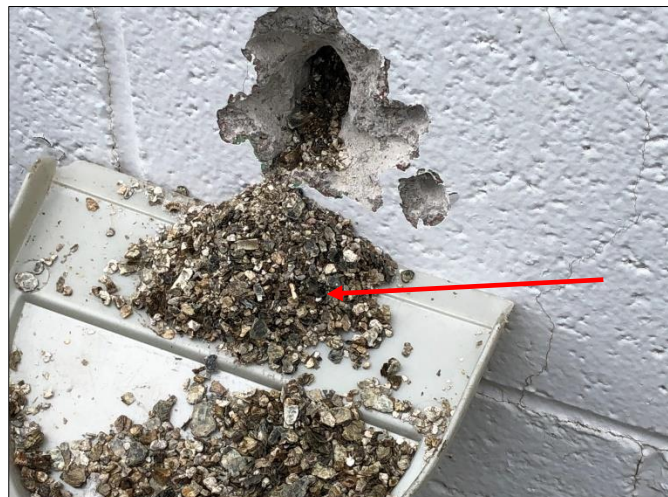
**Vermiculite Insulation**

Sample	Description	Appearance	Non-Asbestos		Asbestos
			% Fibrous	% Non-Fibrous	% Type
31 041829118-0001	Vermiculite	Gray Non-Fibrous Homogeneous		98.25% Non-fibrous (Other)	1.75% Tremolite
32 041829118-0002	Vermiculite	Gray Non-Fibrous Homogeneous		97.75% Non-fibrous (Other)	2.25% Tremolite
33 041829118-0003	Vermiculite	Gray Non-Fibrous Homogeneous		98.25% Non-fibrous (Other)	1.75% Tremolite

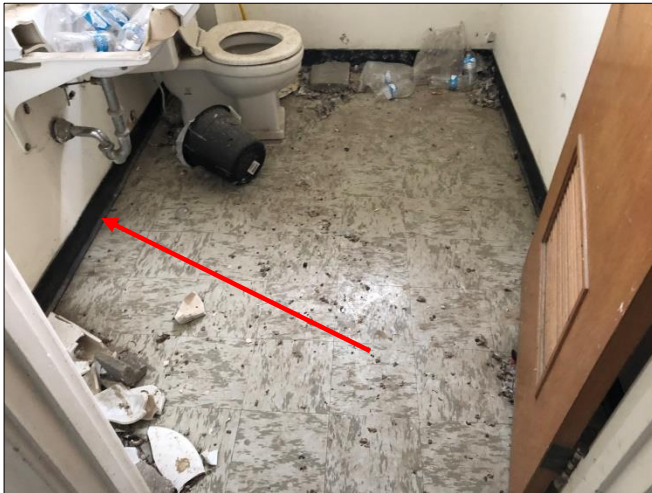
**4" Rubber Base w/Glue**

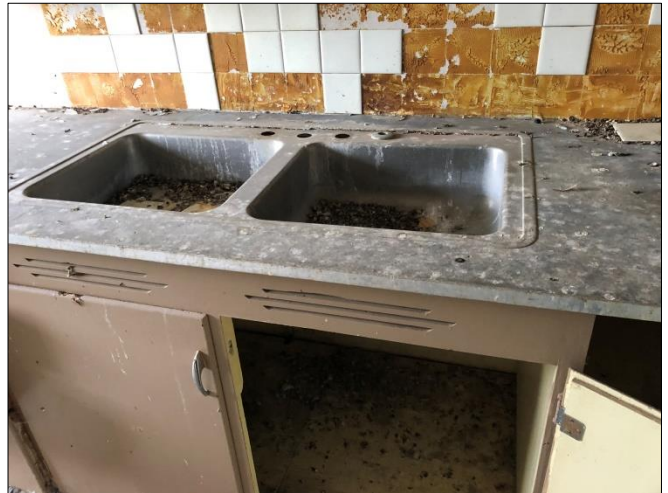
**Stainless Steel Sink w/Insulation**

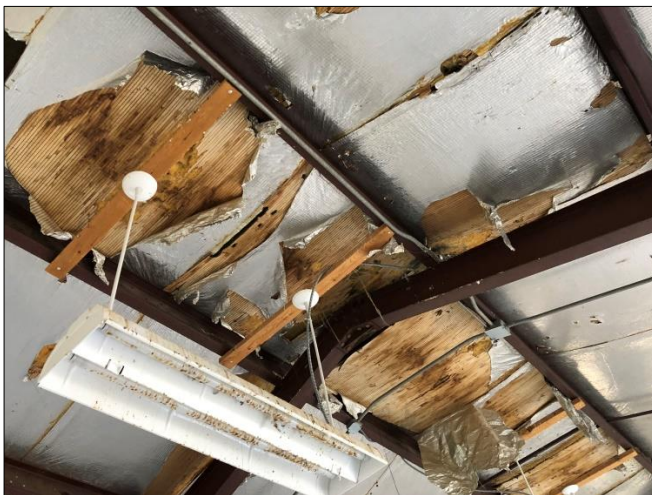
**Fiberglass Insulation Backing**

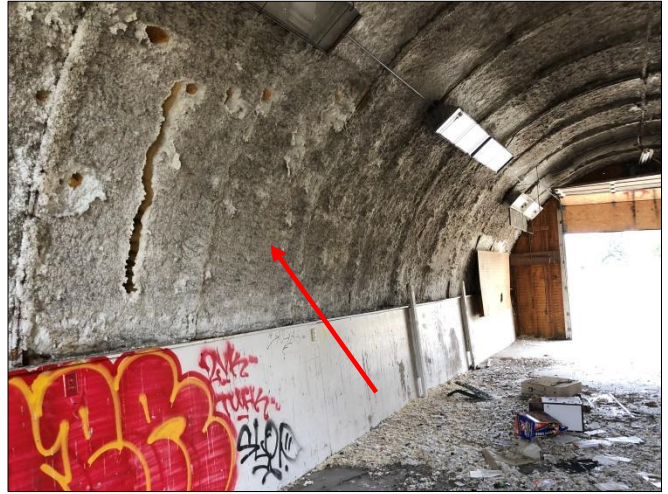
**Insulation in Quonset**

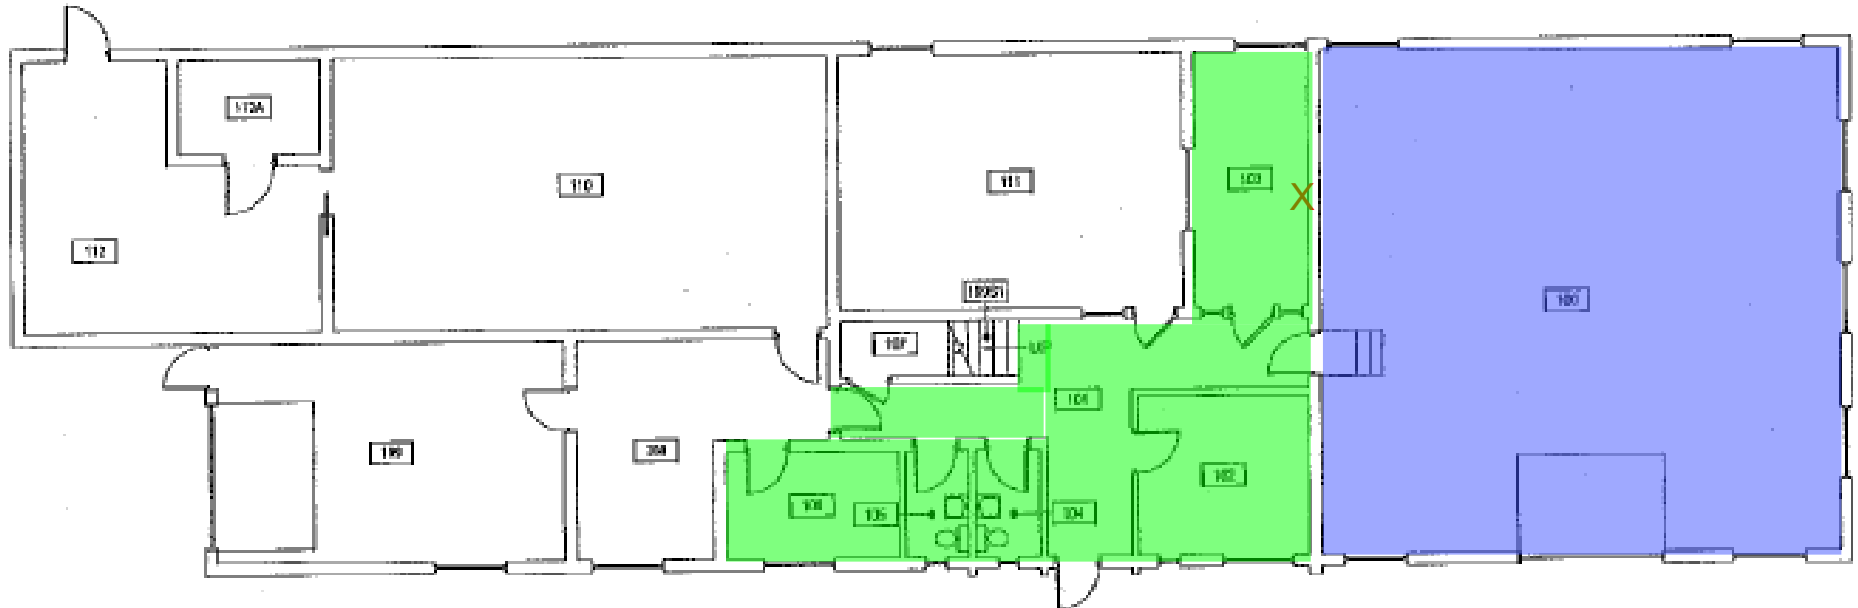
1 NELSON DAIRY CENTER - FIRST LEVEL  
SCALE: 1/8" = 1'

- 9x9 Floor Tile w/Mastic
- Fiberglass Insulation w/Backing
- X Stainless Steel Sink w/Insulation

Additional Materials with >1% Asbestos

All Drywall Walls and Ceilings with Texture and Joint Compound

Vermiculite Insulation - Located Inside CMU Walls
