# PHASE II ENVIRONMENTAL SITE ASSESSMENT

“LA FOUNTAIN PROPERTY”: 301 W. BROADWAY STREET, LEWISTOWN, MT 59457

October 1, 2018

## **Phase II Environmental Site Assessment**

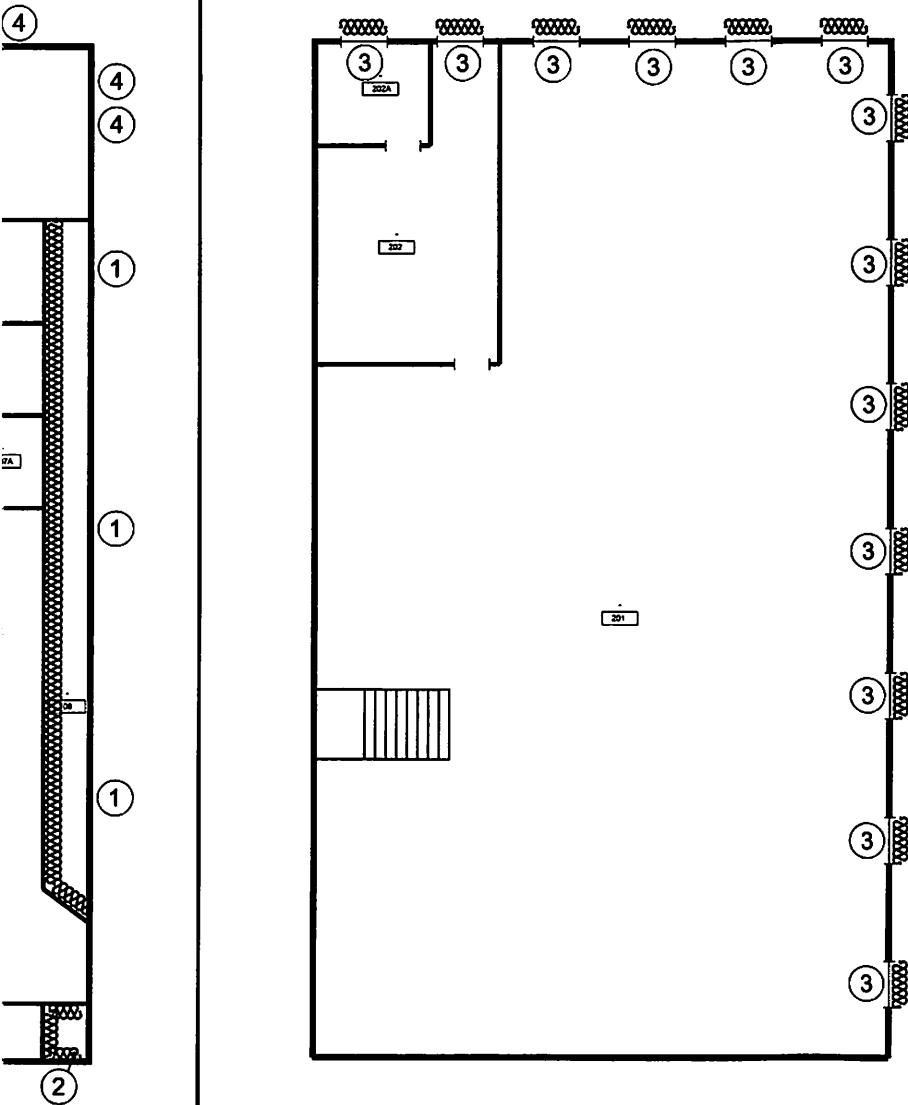
## SECOND FLOOR MATERIAL LOCATION DIAGRAM

1. ASSUMED LEAD BASED PAINT ON 2ND FLOOR EXTERIOR WINDOW CASING AND SASH (INACCESSIBLE)

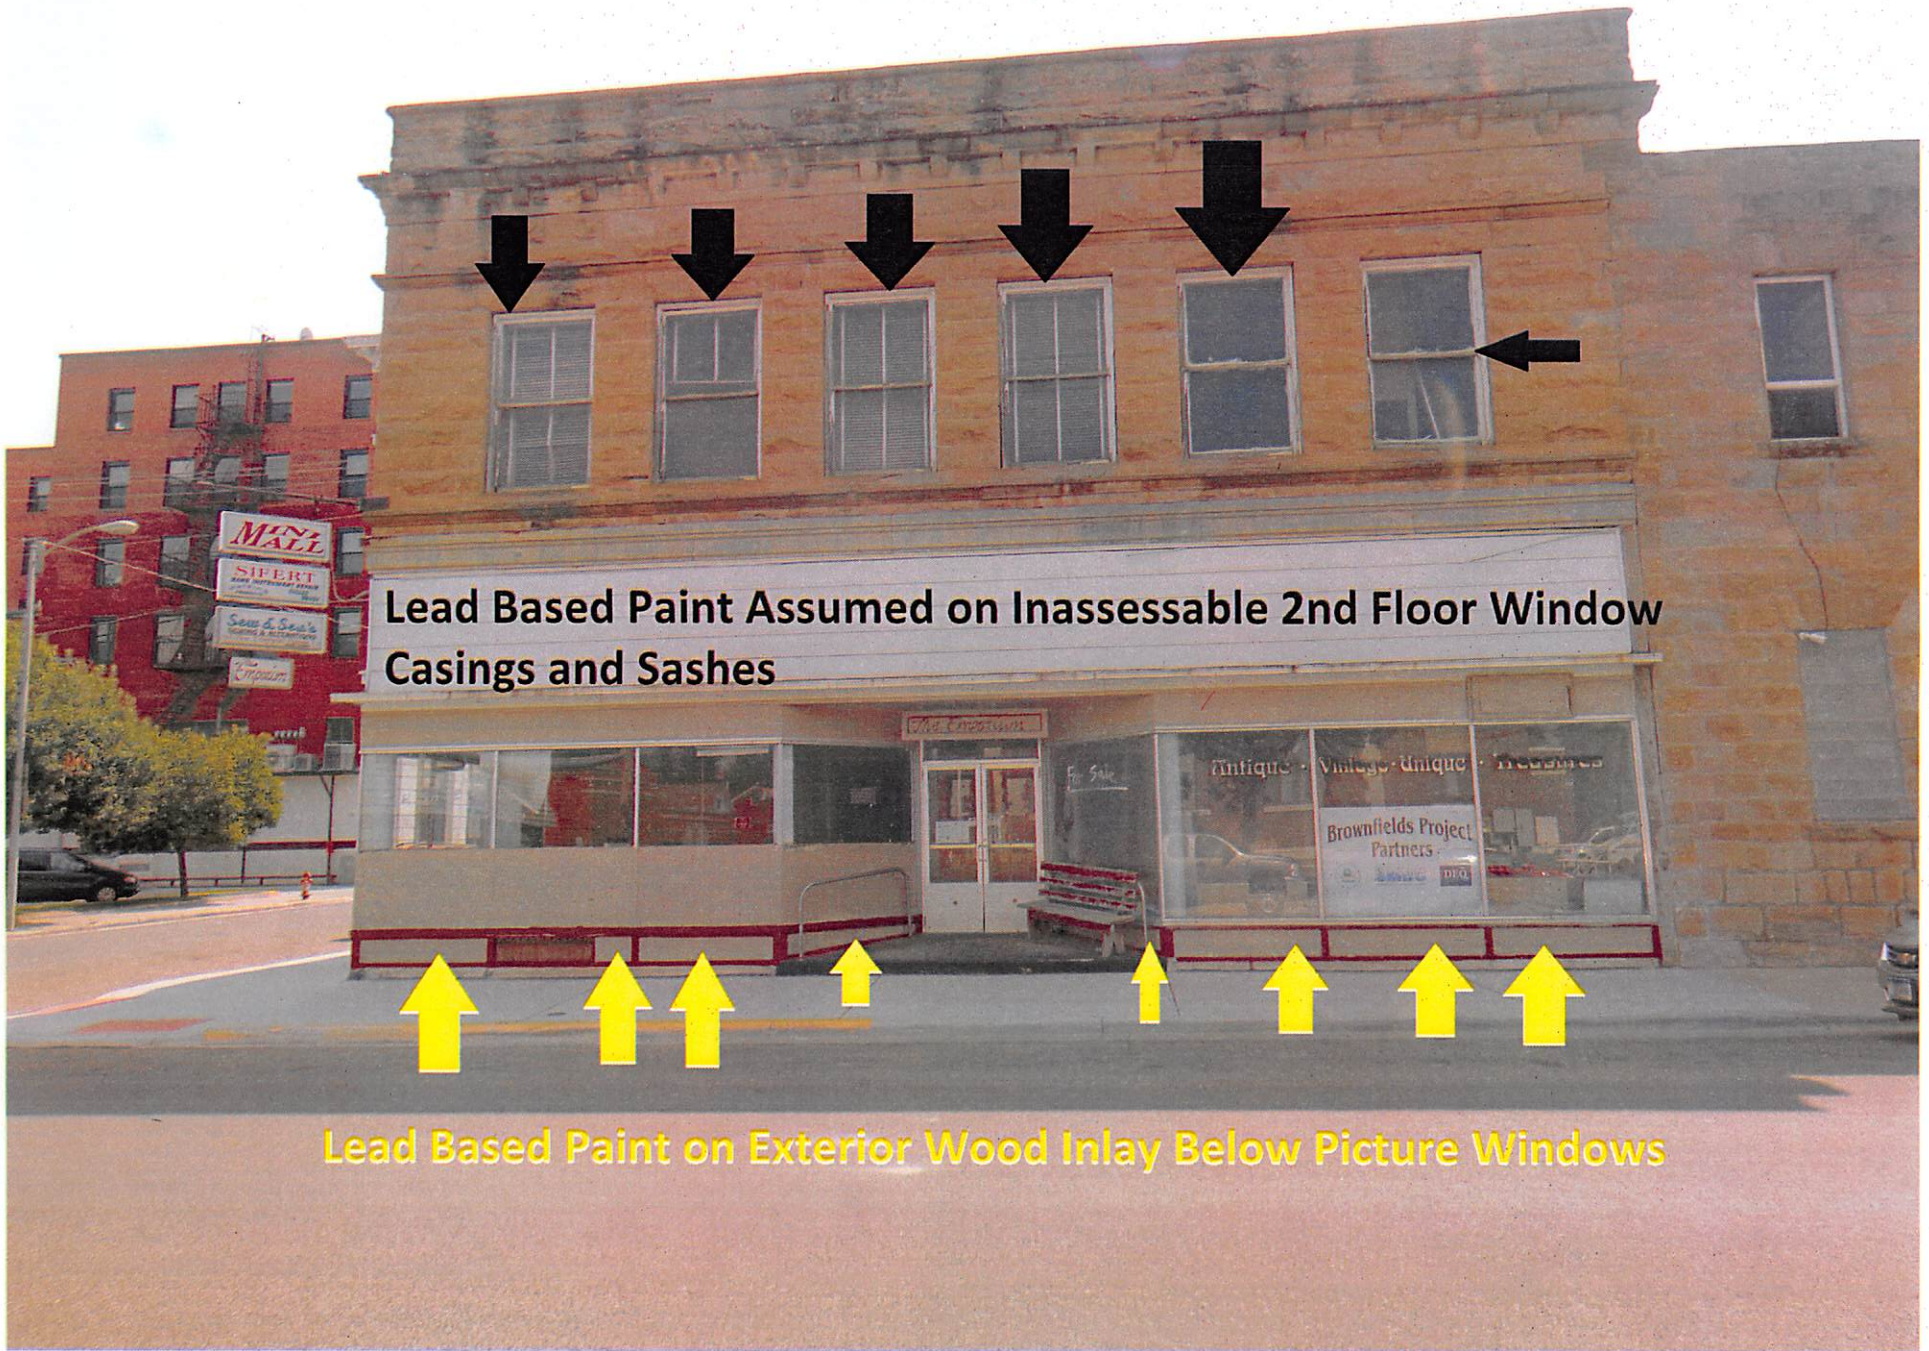
Lead Based Paint Assumed on Inaccessable 2nd Floor Window Casings and Sashes

**Lead Based Paint Assumed on Inaccessible External 2nd Floor Window Casings and Sashes**

- Five of the LBP painted components are in a deteriorated condition, including the 2nd story exterior casing and sash. These components should be cleaned and sealed or removed and replaced. The remaining six intact LBP building components should be noted in case renovation work causes an impact to their condition, creating a potential hazard. If the identified intact LBP components are impacted, the component or paint should be removed.

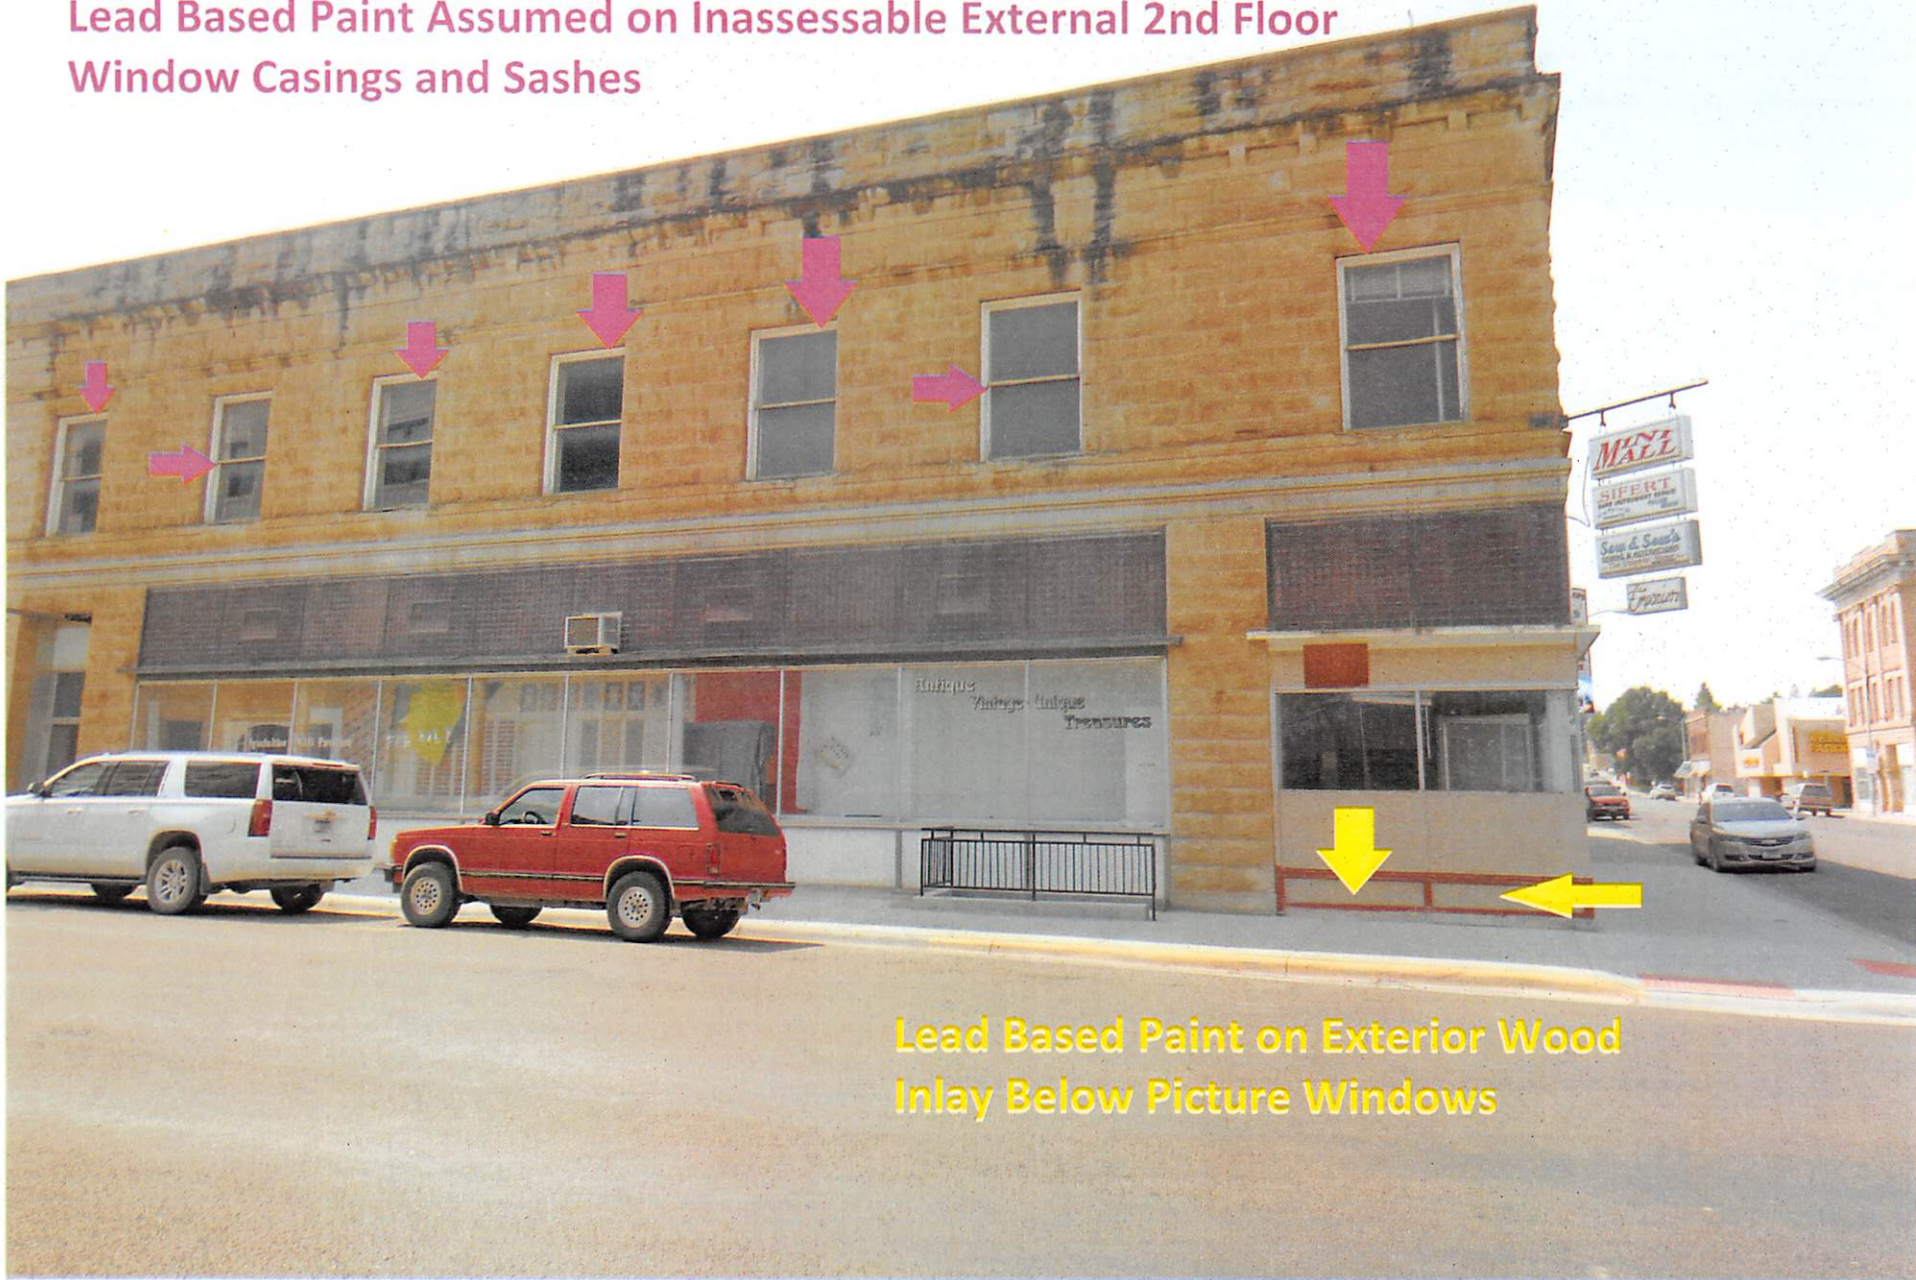
**Lead Based Paint on Exterior Wood Inlay Below Picture Windows**

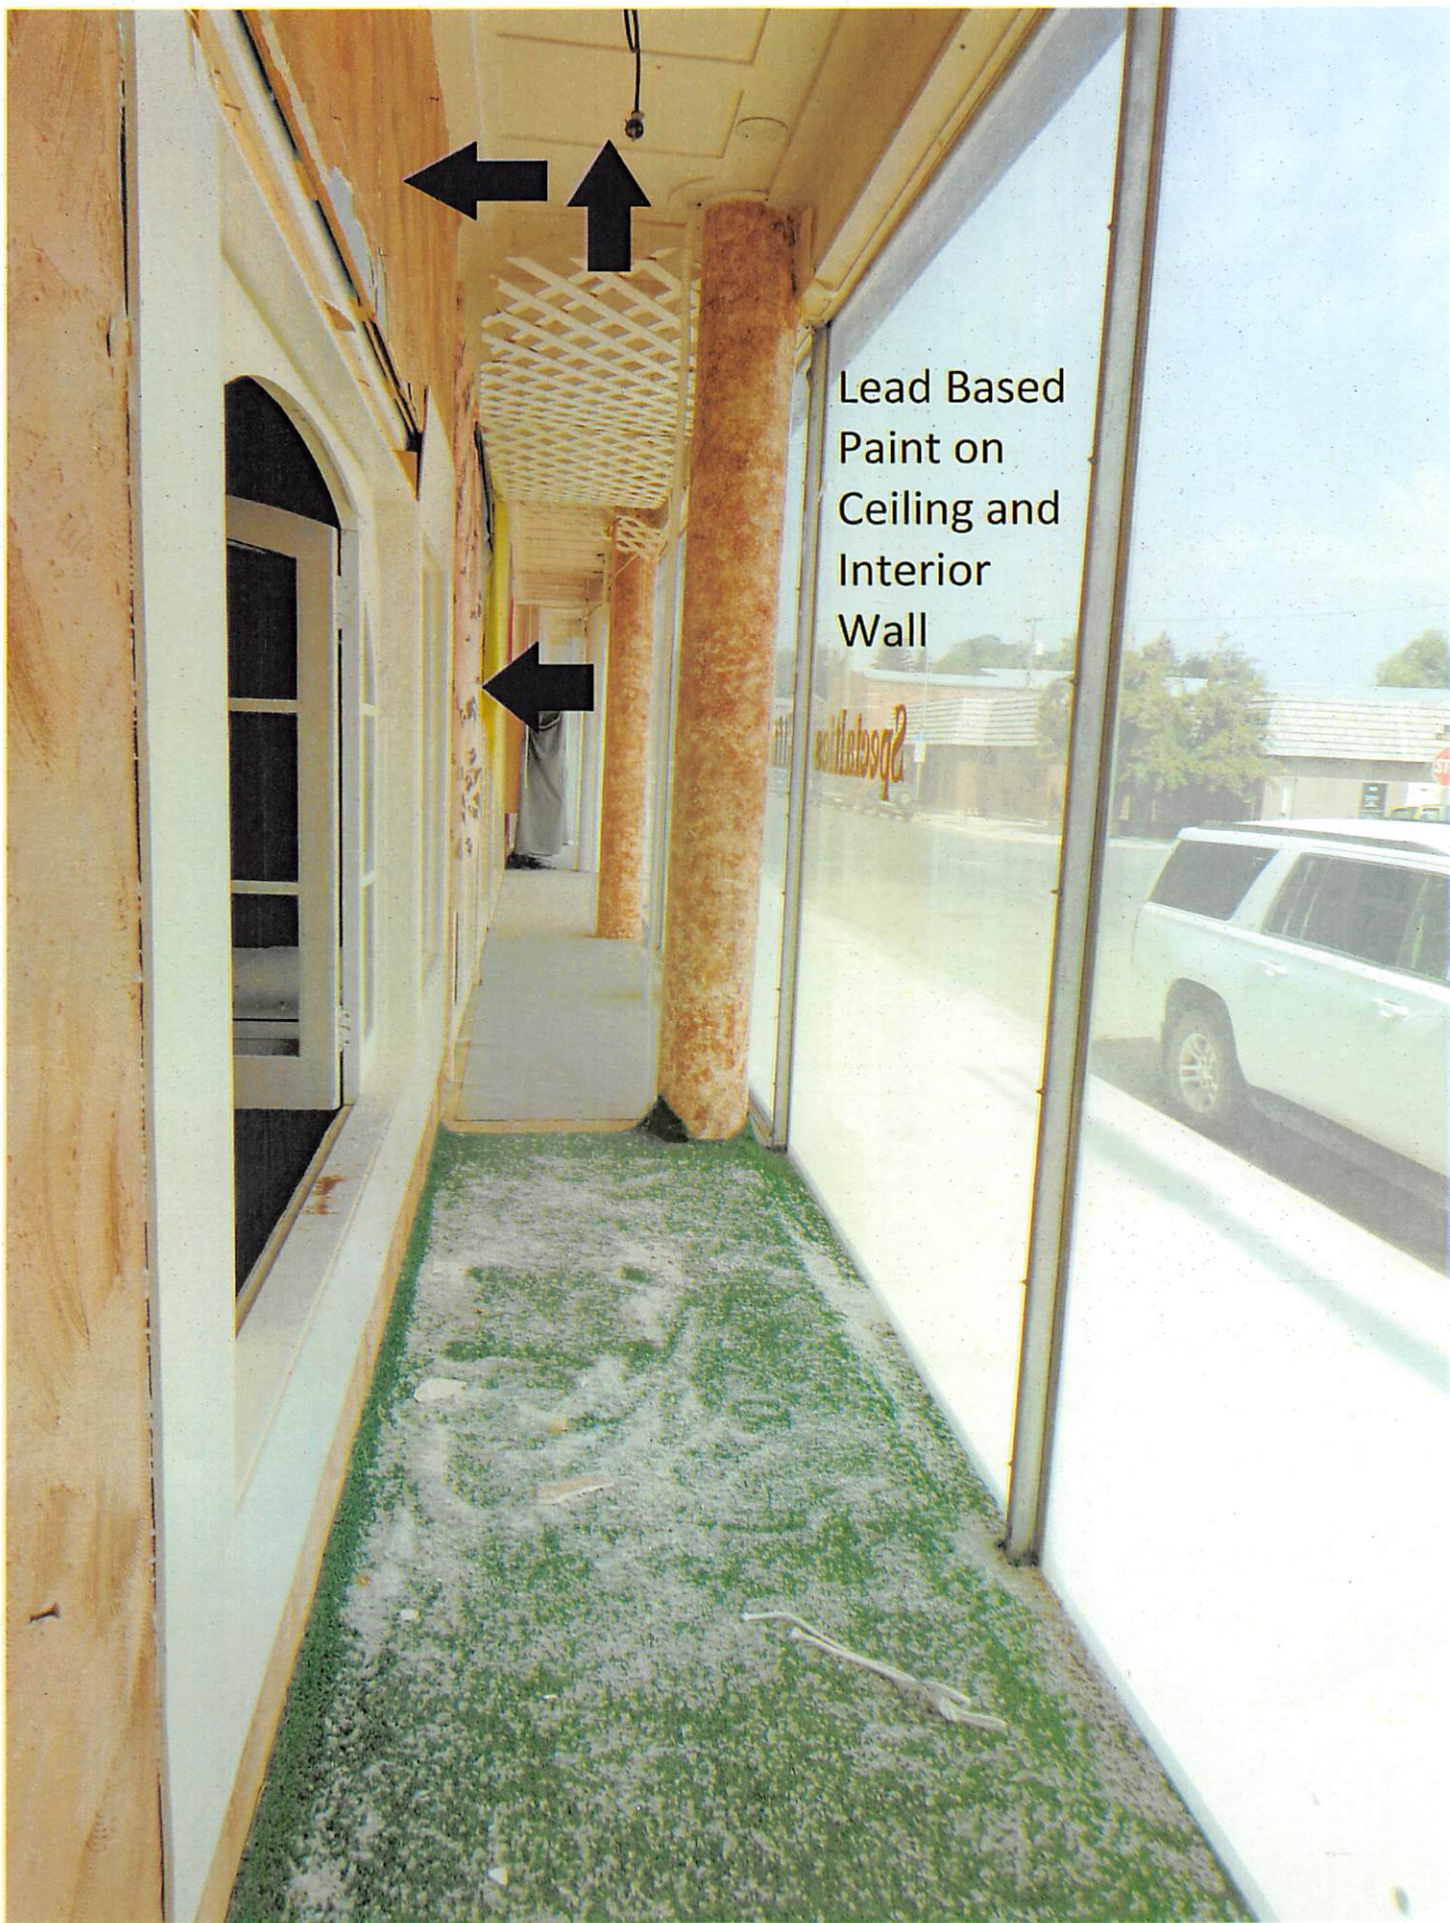
Lead Based  
Paint on  
Ceiling and  
Interior  
Wall

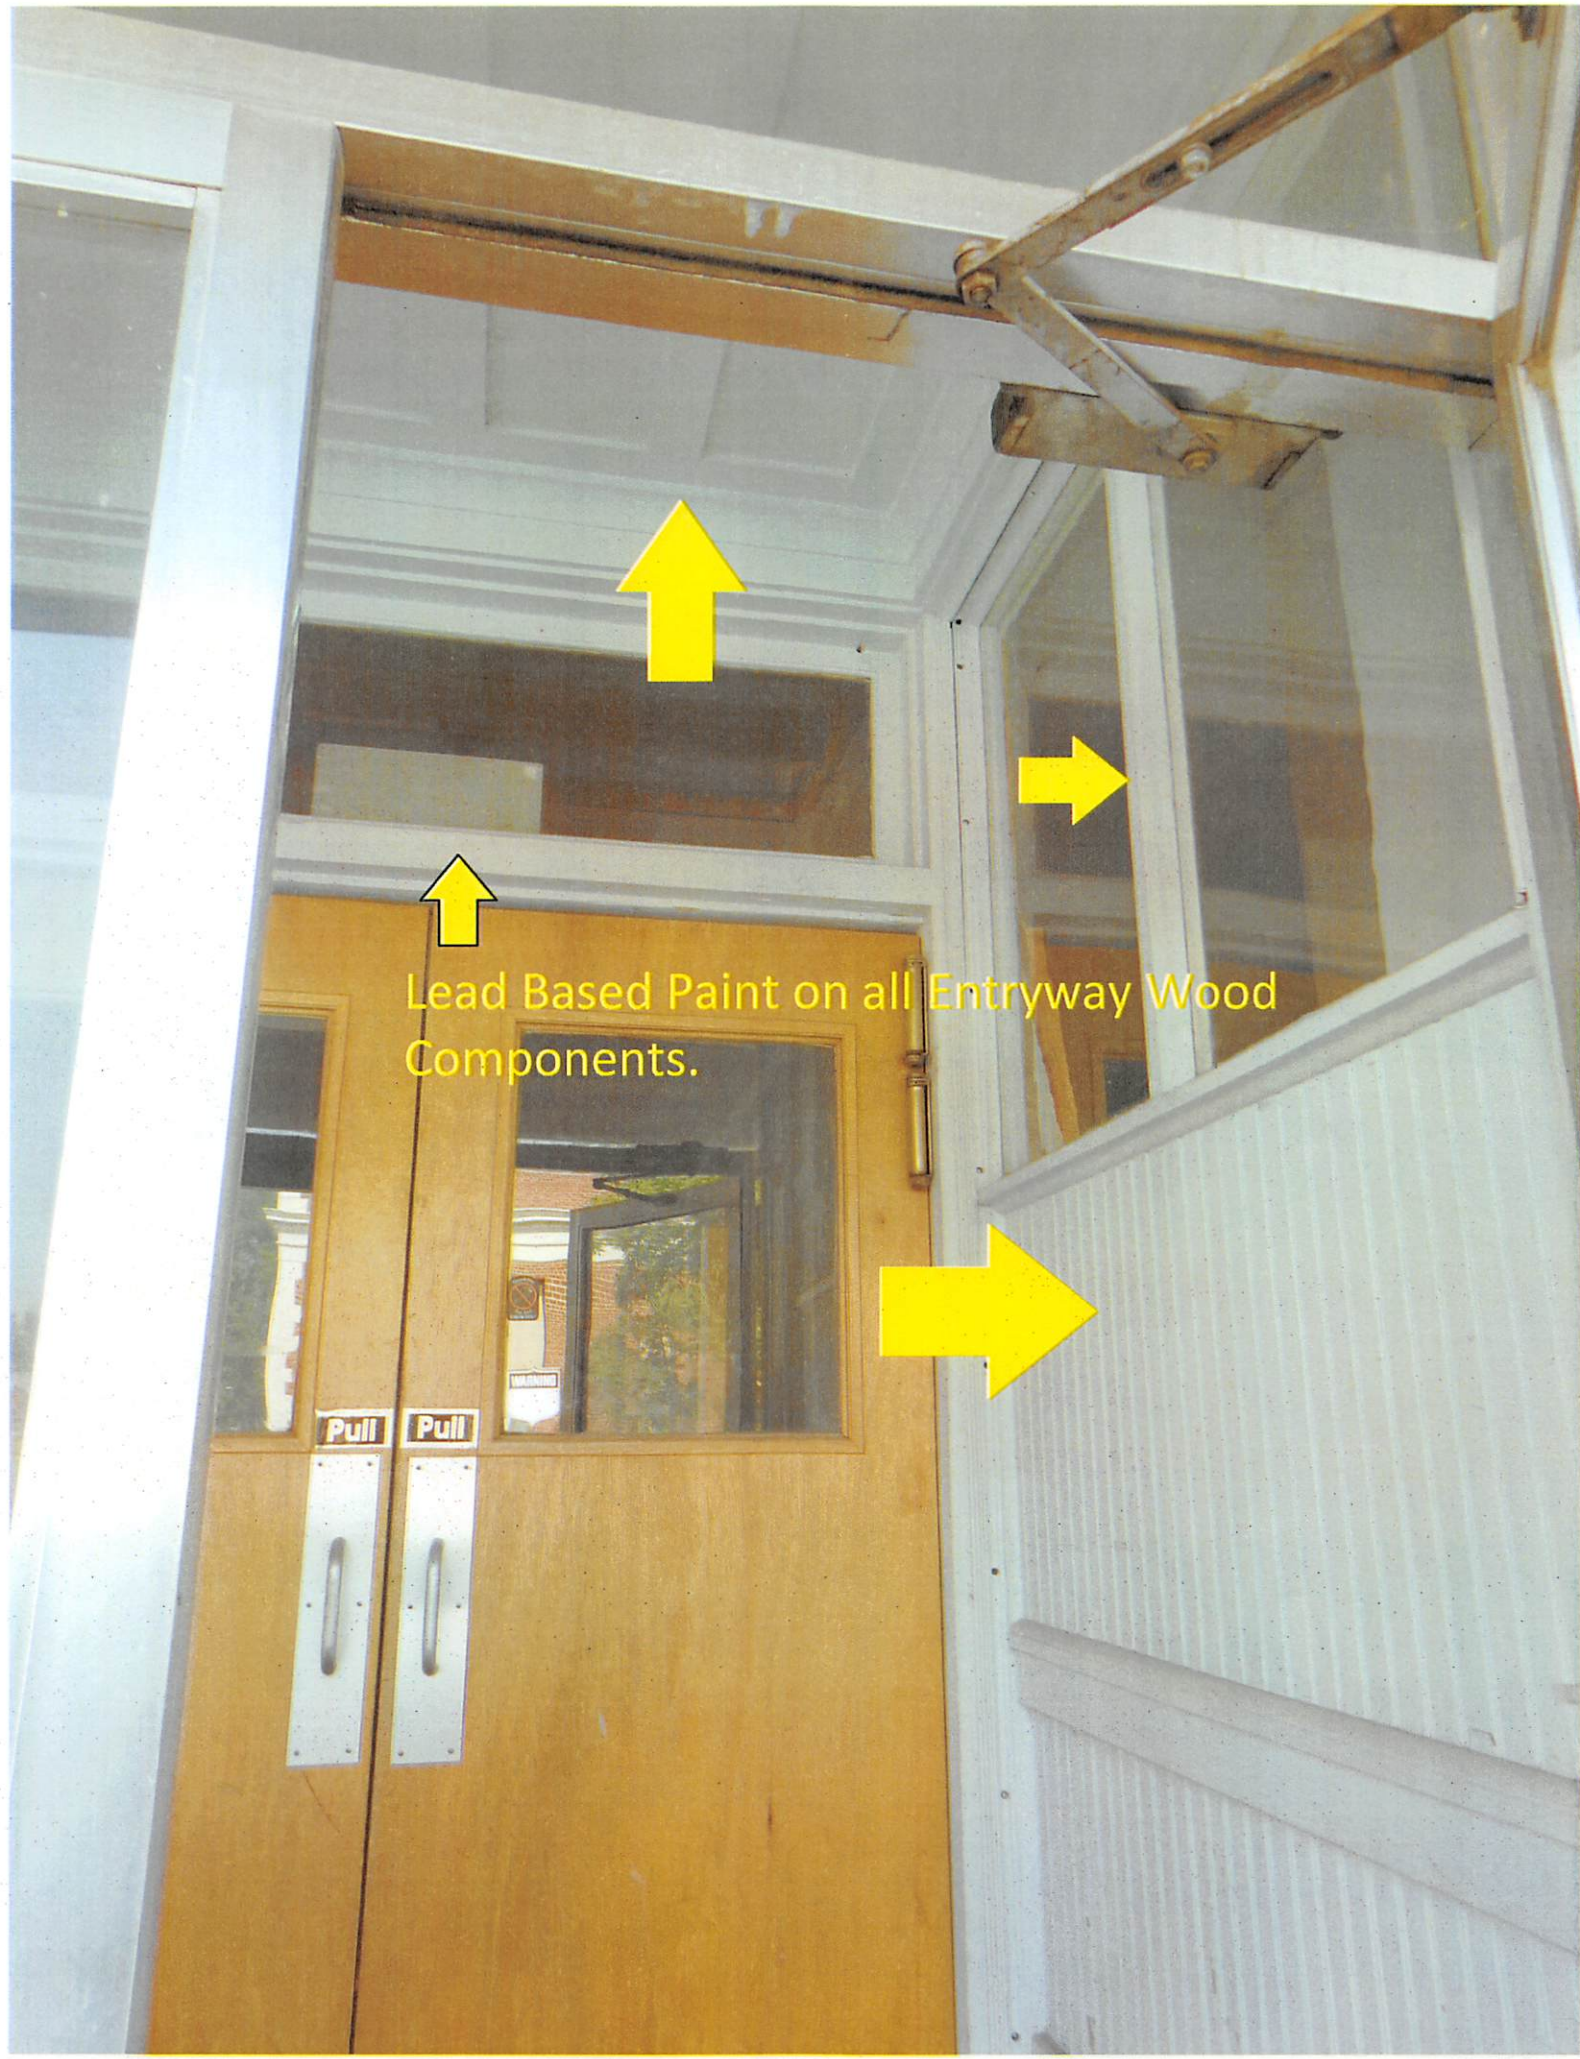
Lead Based Paint on all Entryway Wood Components.

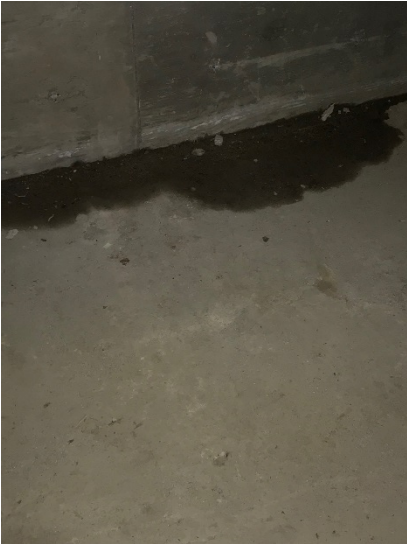
Evidence of water intrusion in basement: no mold observed.

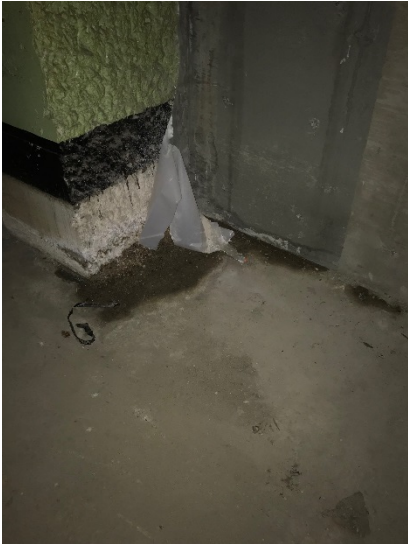
Evidence of water intrusion in basement: no mold observed.

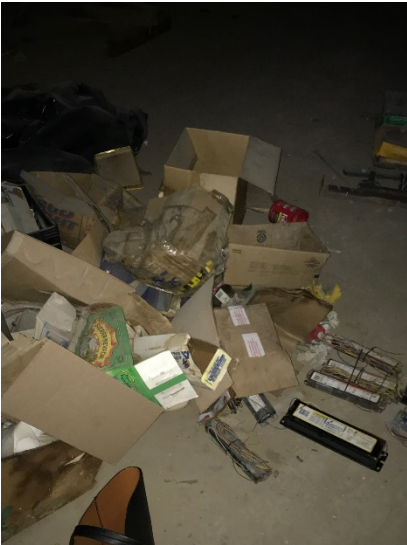
Debris pile in basement: Electronic ballasts observed.

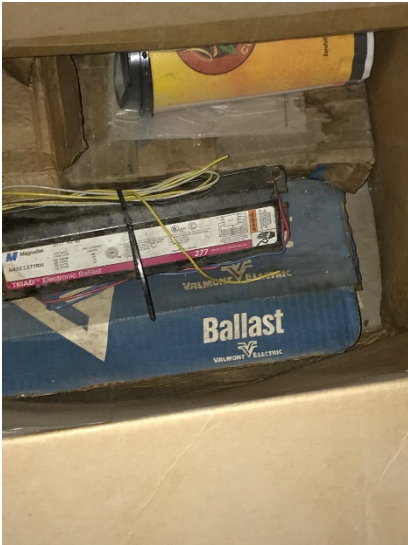
Debris pile in basement: Electronic ballasts observed.

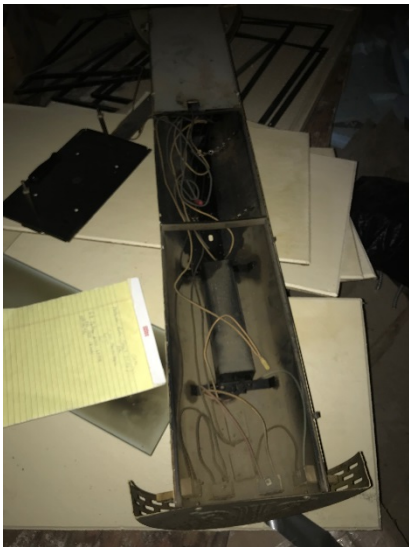
Lighting fixture in basement with presumed leaky PCB ballast.

- PCB-containing equipment identified or encountered should be properly removed prior to relevant renovation or demolition activities, and properly disposed of.
- If mercury-containing thermostat switches are encountered, although none were observed, they should be properly removed prior to relevant renovation or demolition activities and properly disposed of.

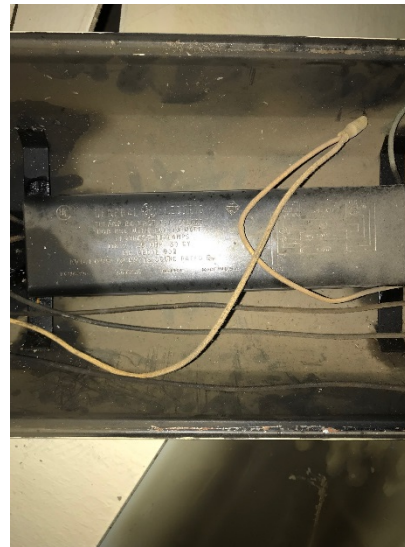
Lighting fixture in basement with presumed leaky PCB ballast.  
Note engraved ballast label.

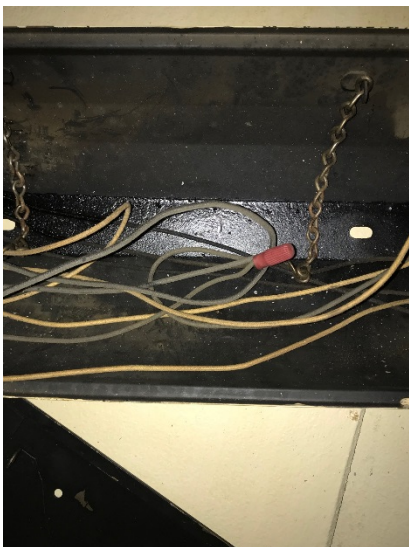
Lighting fixture in basement with presumed leaky PCB ballast.  
Note sheen indicative of a leak.

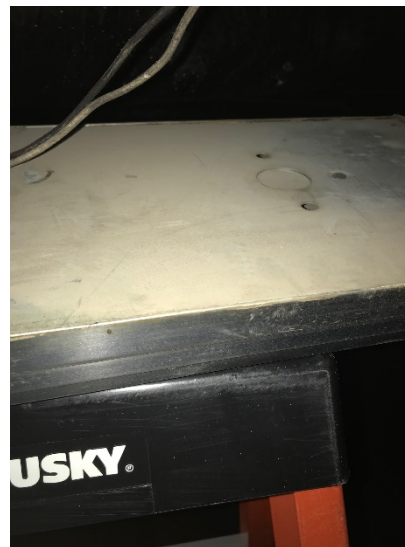
Lighting fixture in basement with presumed PCB ballast.

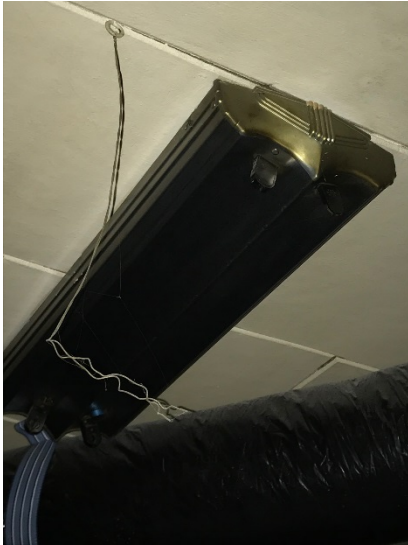
Lighting fixture in basement with presumed PCB ballast.

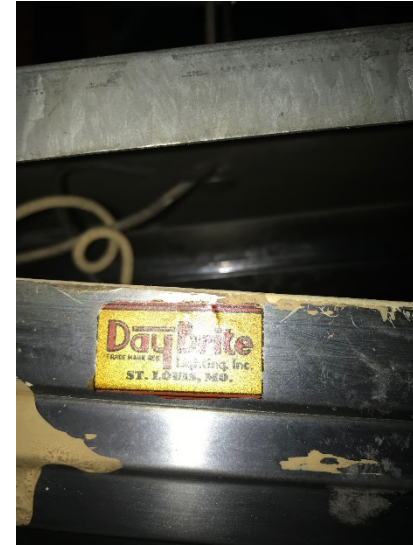
Lighting fixture in basement with presumed PCB ballast.

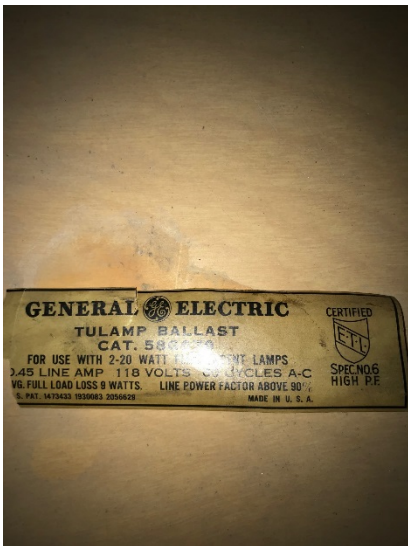
Lighting fixture in basement with presumed PCB ballast.

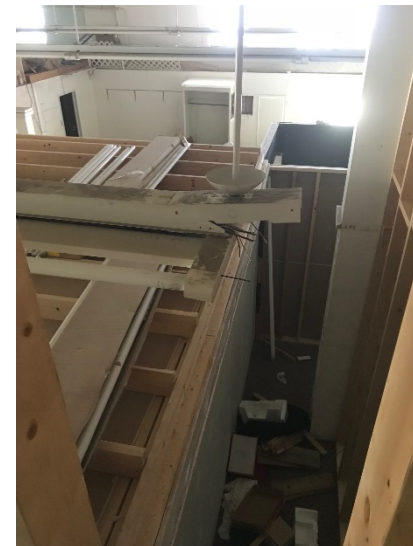
Three rows of similar lighting fixtures on main level.

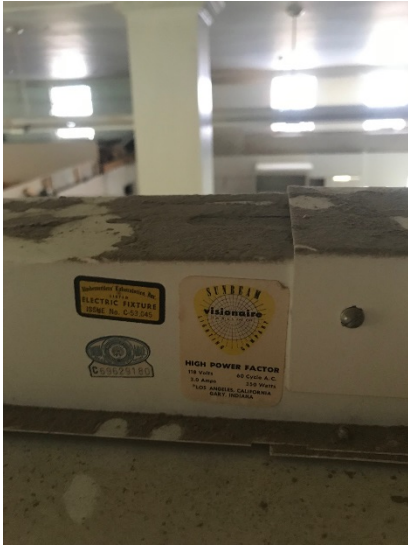
Fixture labeling on main floor.

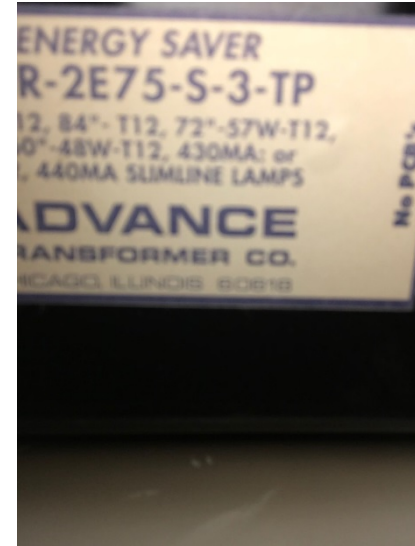
No PCB's labeling observed on a couple ballasts on main level.

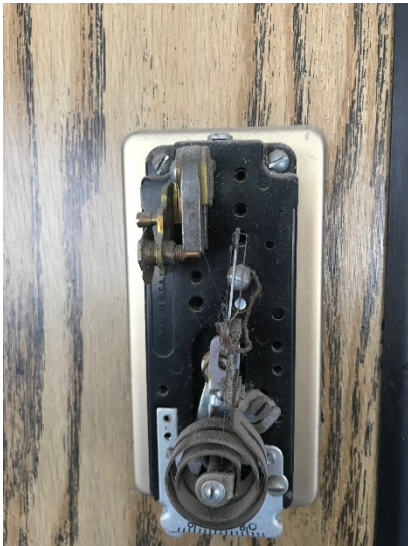
Thermostat on main level with mercury element not observed.
