**Subject: Targeted Brownfields Assessment – Phase I Environmental Site Assessment
Hilger VFD
Section 12, Township 17 North, Range 18 East, Lots 4, 5, and 6, Block 12
Hilger, Fergus County, Montana
U.S. EPA Region 8, START V, Contract No. 68HE082D0001
Task Order No. 82
Technical Direction No. 2010-12
Work Assignment Manager: Greg Davis**

**TARGETED BROWNFIELDS ASSESSMENT
PHASE I ENVIRONMENTAL SITE ASSESSMENT**

**HILGER VFD
SECTION 12, TOWNSHIP 17 NORTH, RANGE 18 EAST
LOTS 4, 5, AND 6, BLOCK 12
HILGER, MONTANA**

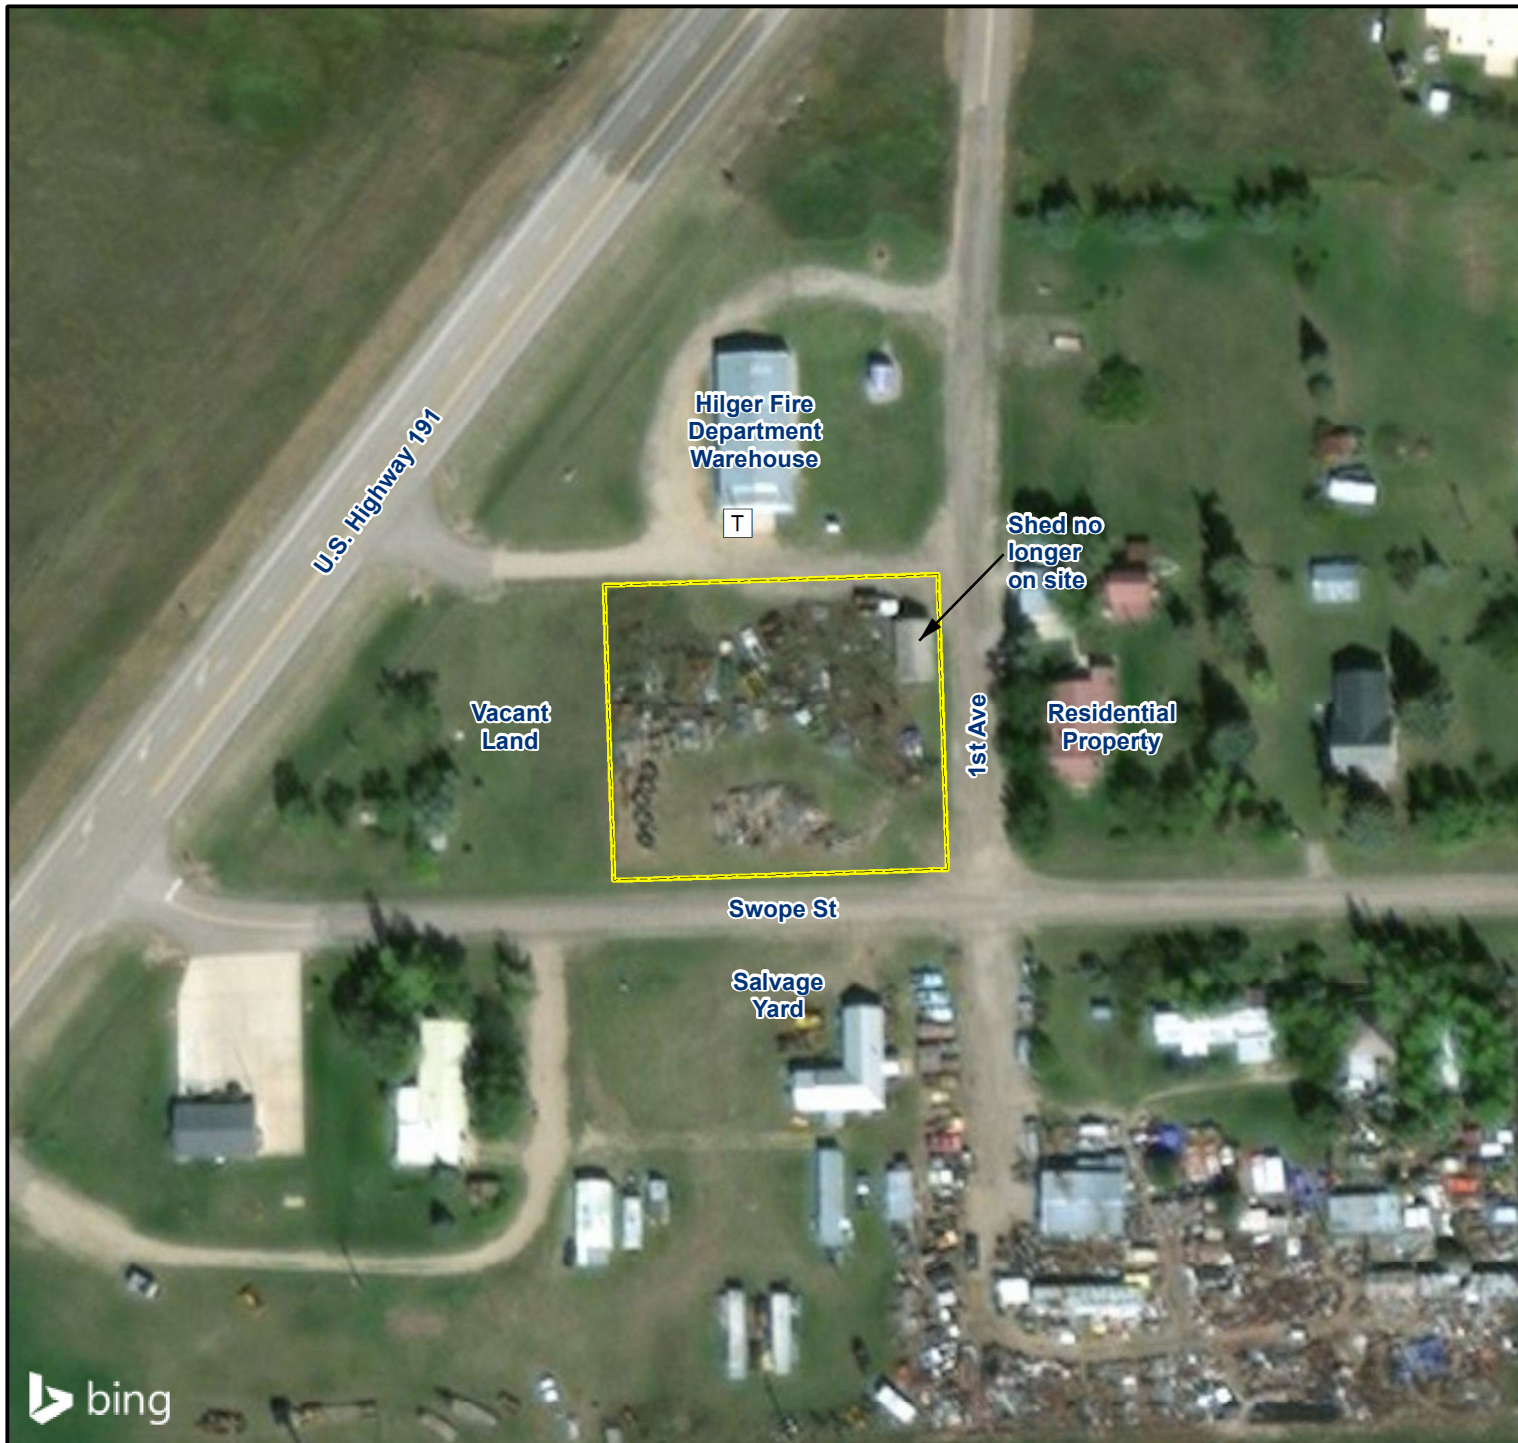
FIGURE 2

The 0.482-acre subject property is currently an unoccupied lot with no structures. The subject property is bounded to the north by a gravel road followed by the Hilger Fire District warehouse; to the east by 1st Avenue followed by residential properties; to the south by Swope Street followed by a permanently closed salvage yard; and to the west by vacant land followed by U.S. Highway 191. Figure 2 in Appendix A illustrates the subject property features.

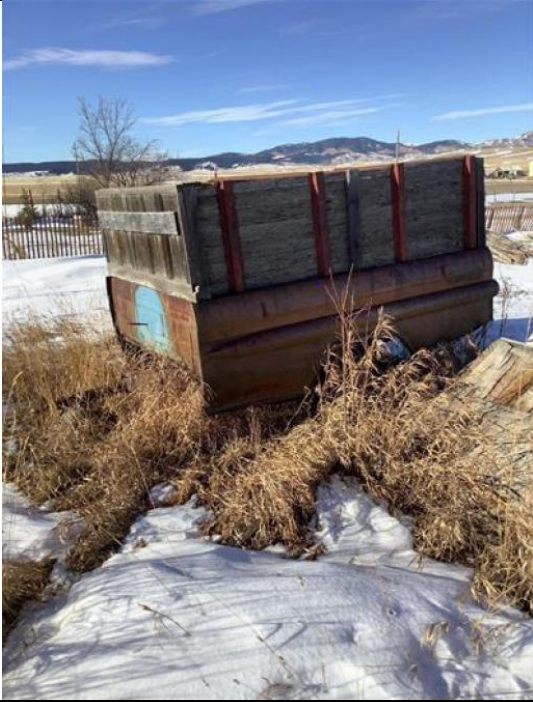
Photo: 1

Direction: West		
Description: A view of a trailer on the west side of the subject property.		
Date: December 4, 2020

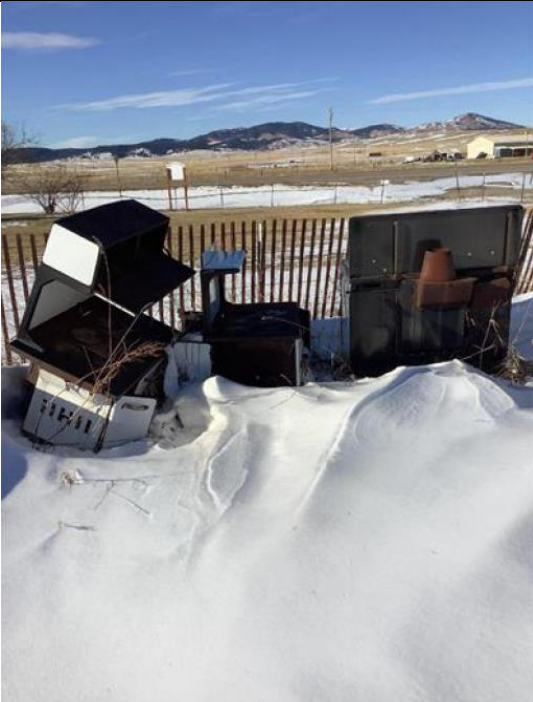
Photo: 2

Direction: West		
Description: A view of three stoves near the western border of the subject property.		
Date: December 4, 2020

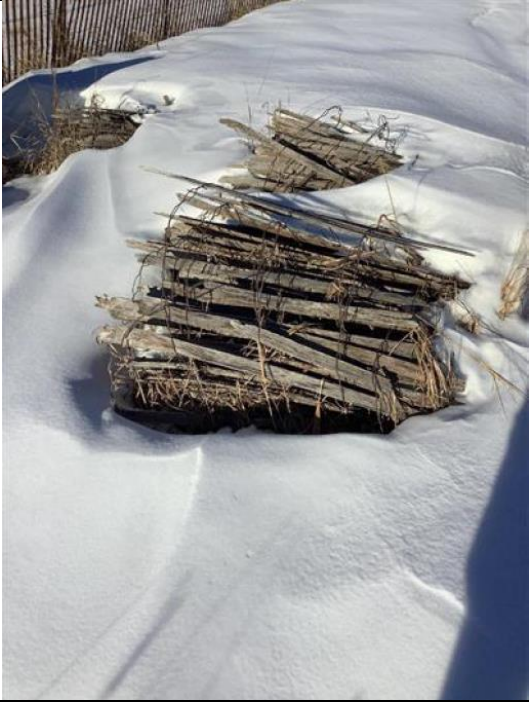
Photo: 3

Direction: NA		
Description: A view of a fence pile near the west side of the subject property.		
Date: December 4, 2020

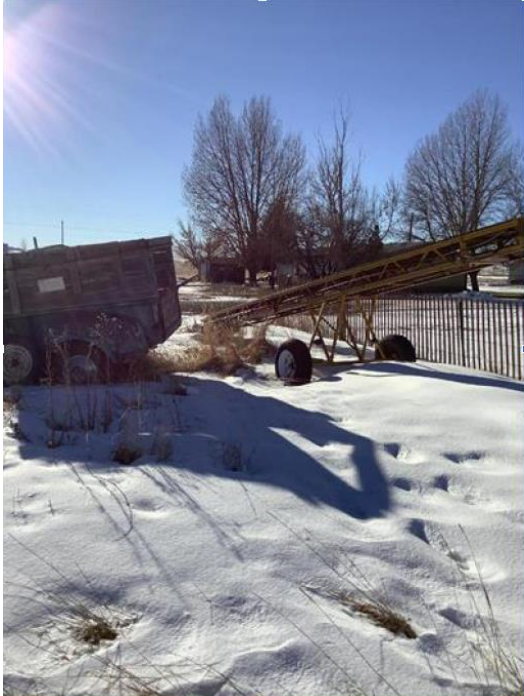
Photo: 5

Direction: Southwest		
Description: A view of a trailer and agricultural machinery near the southwest corner of the subject property.		
Date: December 4, 2020

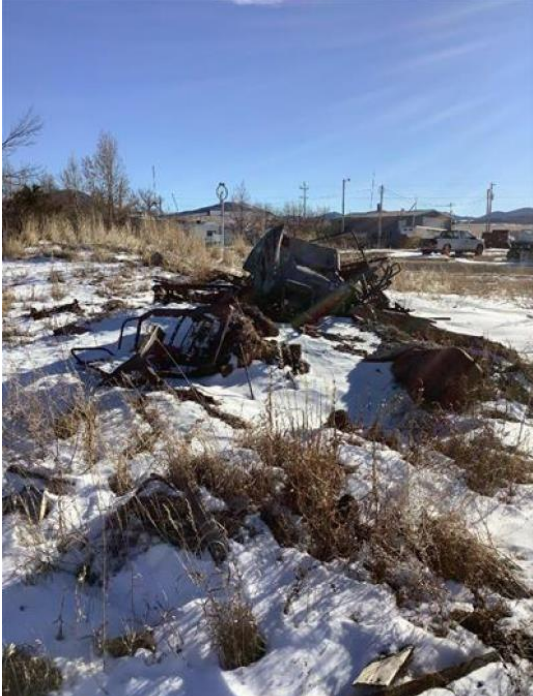
Photo: 7

Direction: Southwest		
Description: A view of a large scrap metal pile near the center of the subject property.		
Date: December 4, 2020

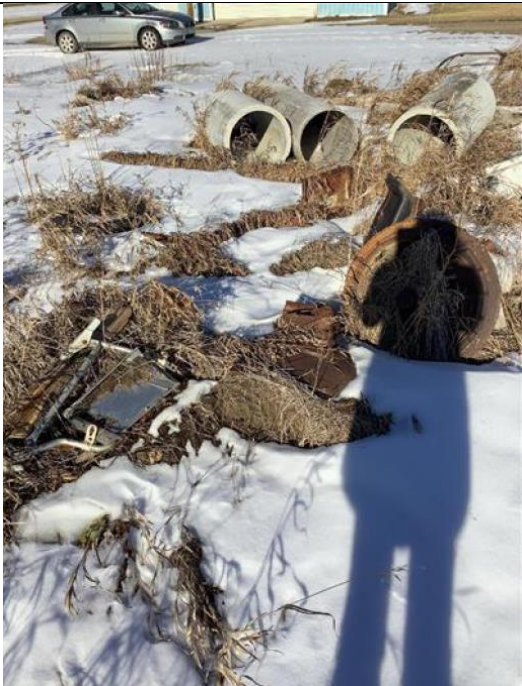
Photo: 8

Direction: NA		
Description: A view of a small scrap metal pile and concrete piping near the northern boundary of the subject property.		
Date: December 4, 2020

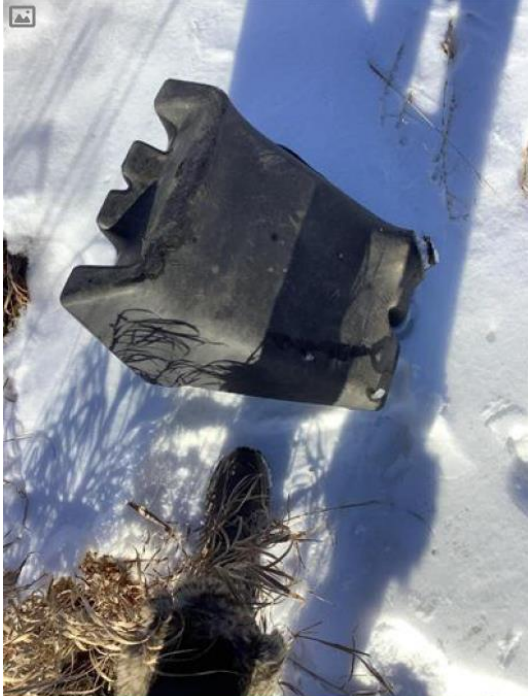
Photo: 9

One empty fuel container was observed on the subject property during the site reconnaissance. No staining was observed in the vicinity of the container. The presence of the fuel container does not pose a REC to the subject property.

Direction: NA		
Description: A view of a small plastic gasoline tank on the subject property.		
Date: December 4, 2020

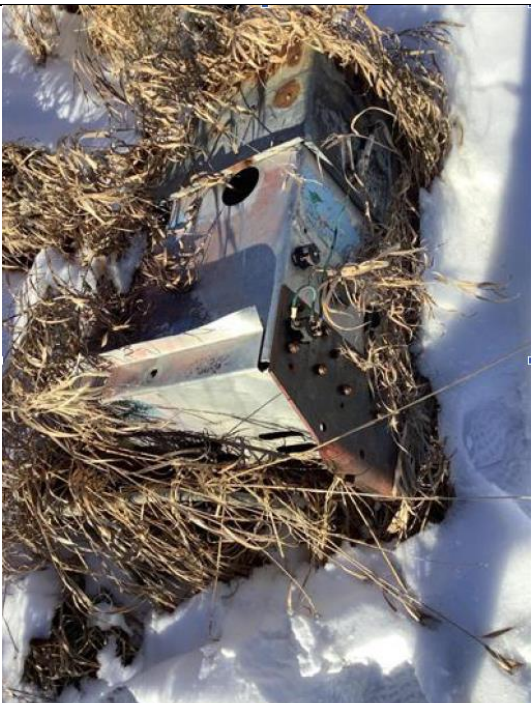
Photo: 10

Direction: NA		
Description: A view of electronic scrap on the subject property.		
Date: December 4, 2020

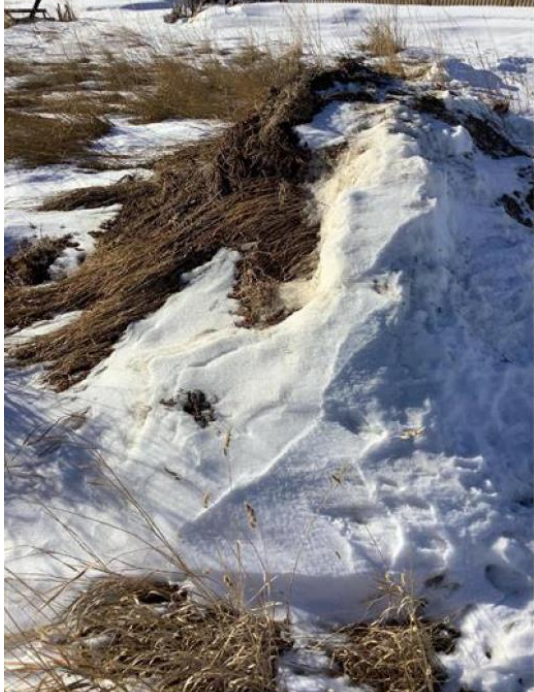
Photo: 11

Direction: NA	
Description: A view of a soil pile near the center of the subject property.	
Date: December 4, 2020

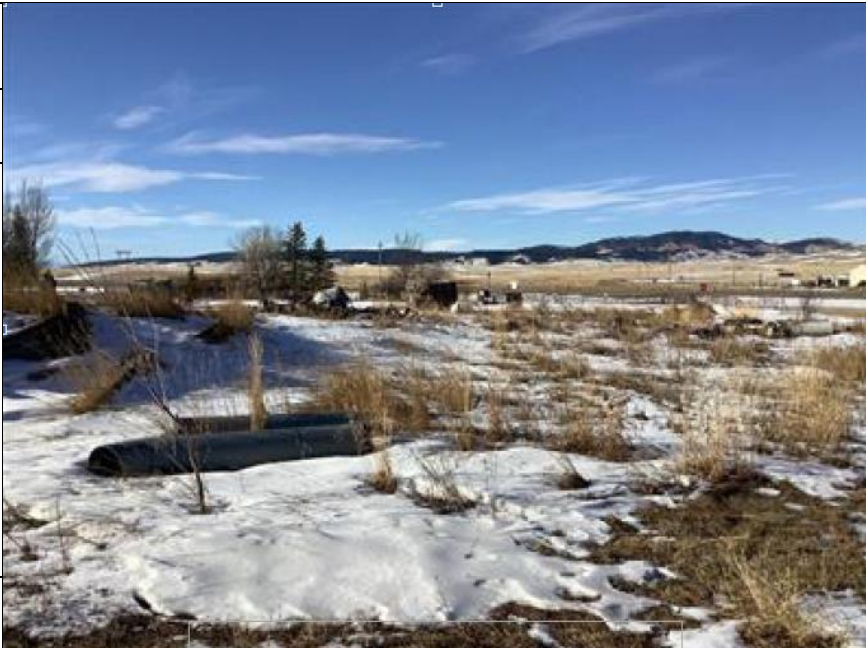
Photo: 12

Direction: West	
Description: A topographic view of the subject property and nearby features.	
Date: December 4, 2020

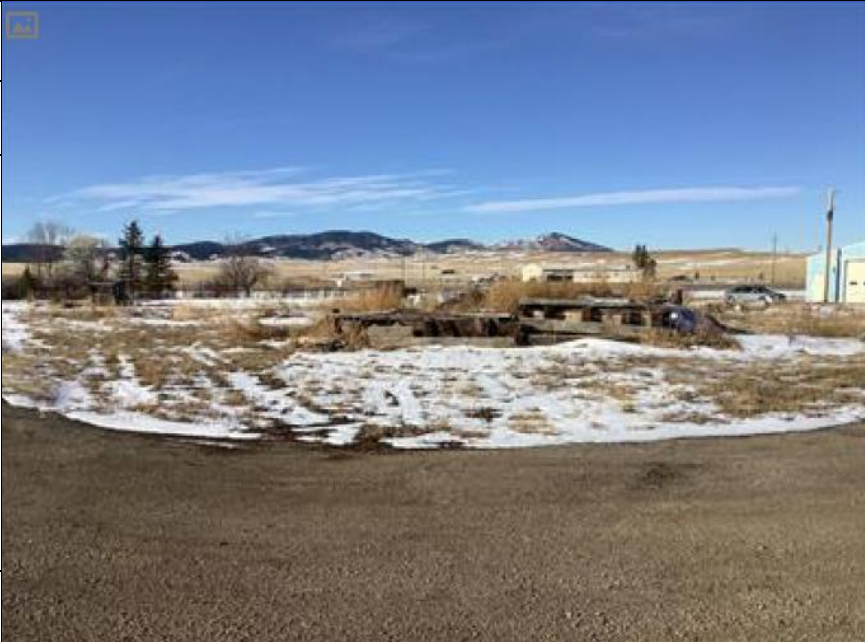
Photo: 13

Direction: Northwest	
Description: A view from the southeast corner of the subject property (intersection of Swope Street and 1st Avenue).	
Date: December 4, 2020

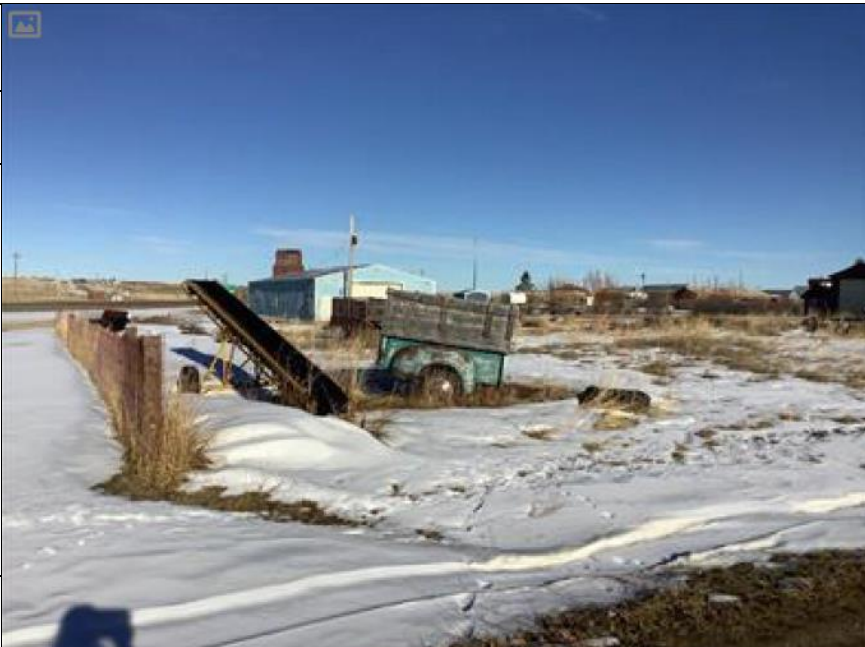
Photo: 14

Direction: Northeast	
Description: A view from the southwest corner of the subject property (Swope Street).	
Date: December 4, 2020

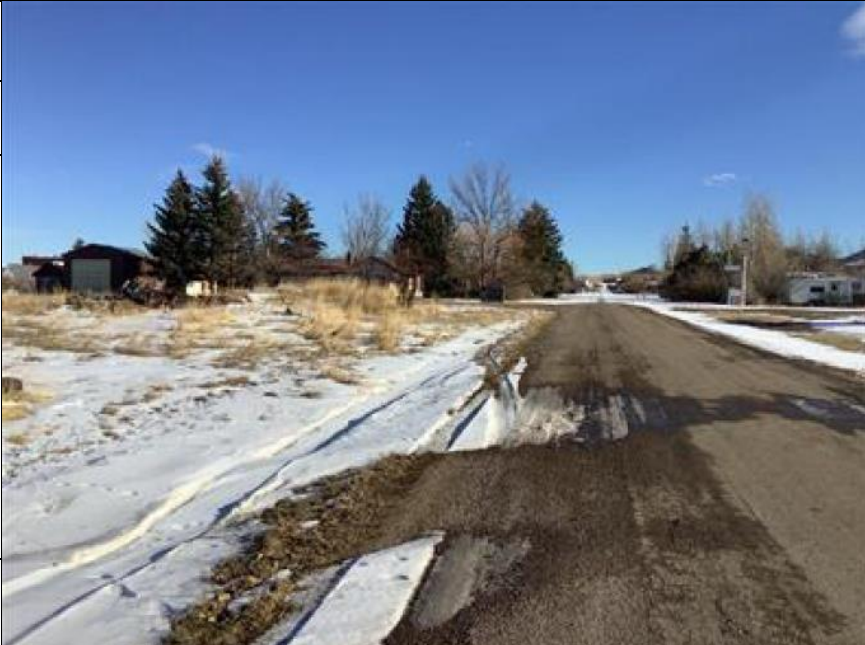
Photo: 15

Direction: East	
Description: A view of the southern boundary of the subject property and the adjacent street (Swope Street).	
Date: December 4, 2020

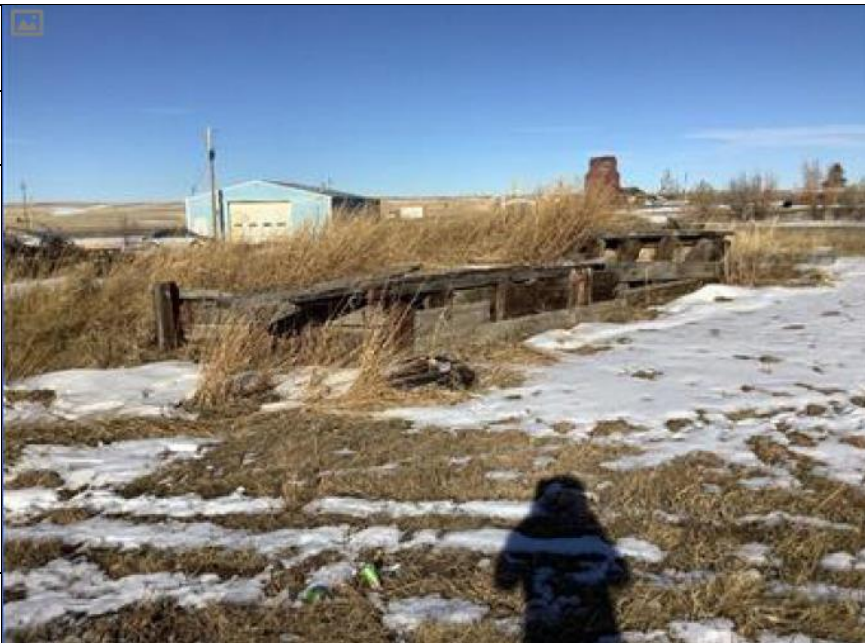
Photo: 16

The subject property is currently an unoccupied lot with no structures. A wooden fence runs along the western boundary of the subject property. One wooden berm-like structure was observed on the southeast corner of the subject property. Based on street view imagery from 2015, the wooden structure appears to have been part of a former loading ramp made of bermed soil (Microsoft Bing Maps 2020). The loading ramp was no longer present during the site reconnaissance.

Direction: North	
Description: A view of a wooden berm-like structure on the southeastern side of the subject property. The structure was previously part of a loading ramp.	
Date: December 4, 2020

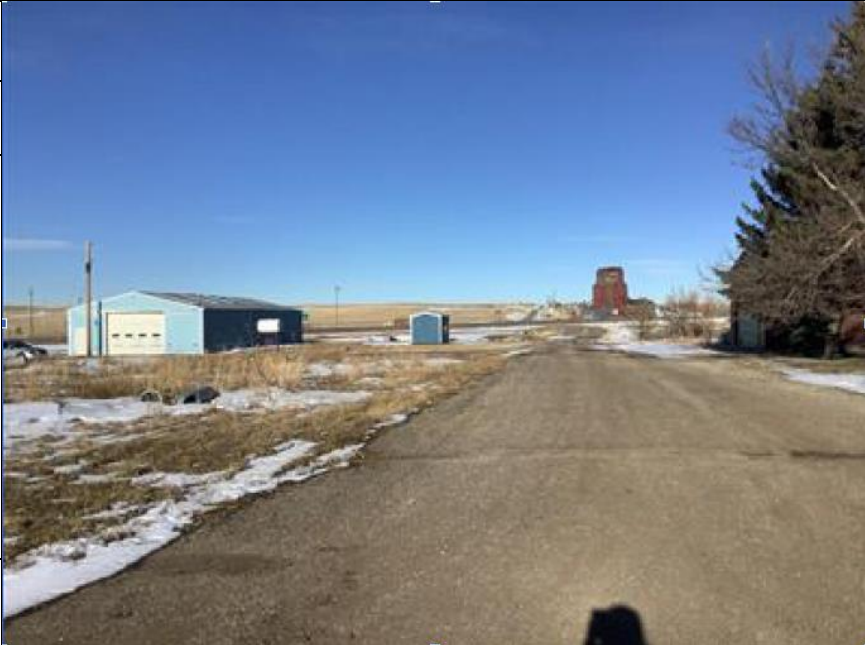
Photo: 17

Direction: NA	
Description: A view of the eastern boundary of the subject property and adjacent street (1st Avenue).	
Date: December 4, 2020

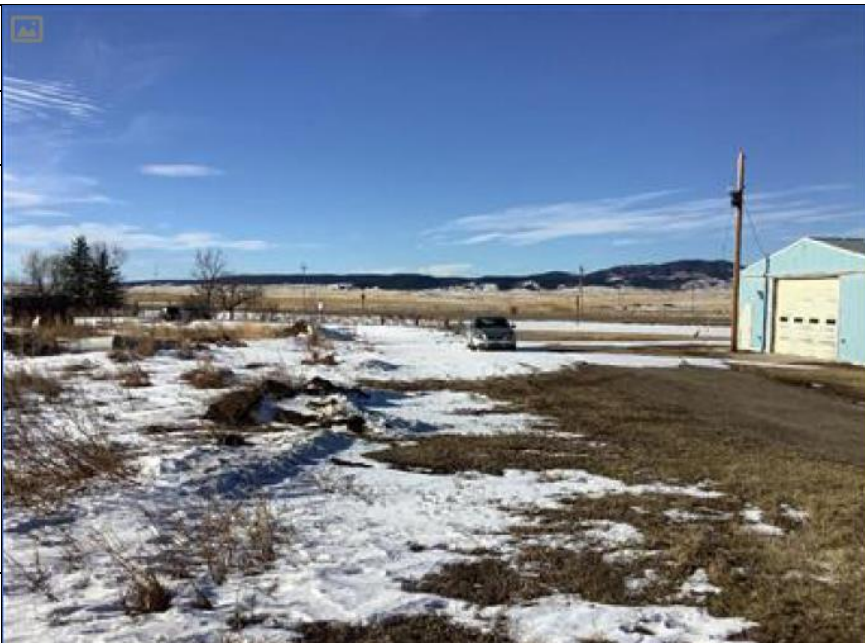
Photo: 18

Direction: West	
Description: A view of the northern boundary of the subject property and adjacent unnamed gravel road.	
Date: December 4, 2020

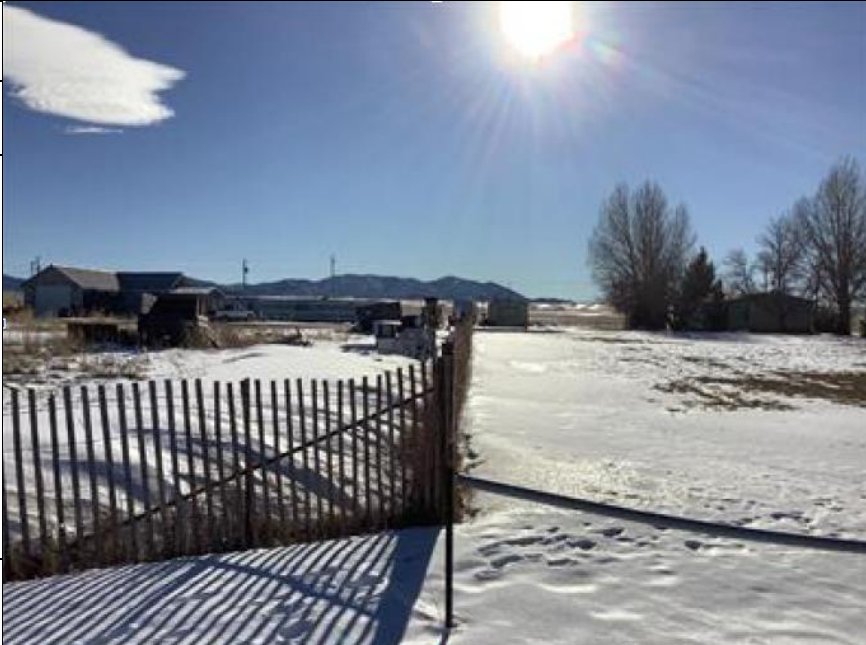
Photo: 19

Direction: South	
Description: A view of the fence line marking the western boundary of the subject property.	
Date: December 4, 2020

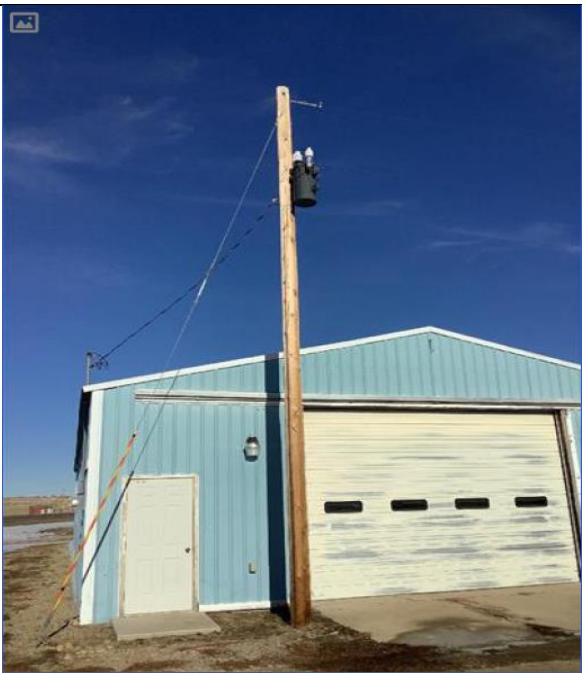
Photo: 20

Direction: North	
Description: A view of pole-mounted transformer at the fire station on the adjacent property to the north of the subject property.	
Date: December 4, 2020
