Phase II Environmental Site Assessment

Old Winnett City Hall

116 Broadway Avenue

Winnett, Petroleum County, Montana, 59087

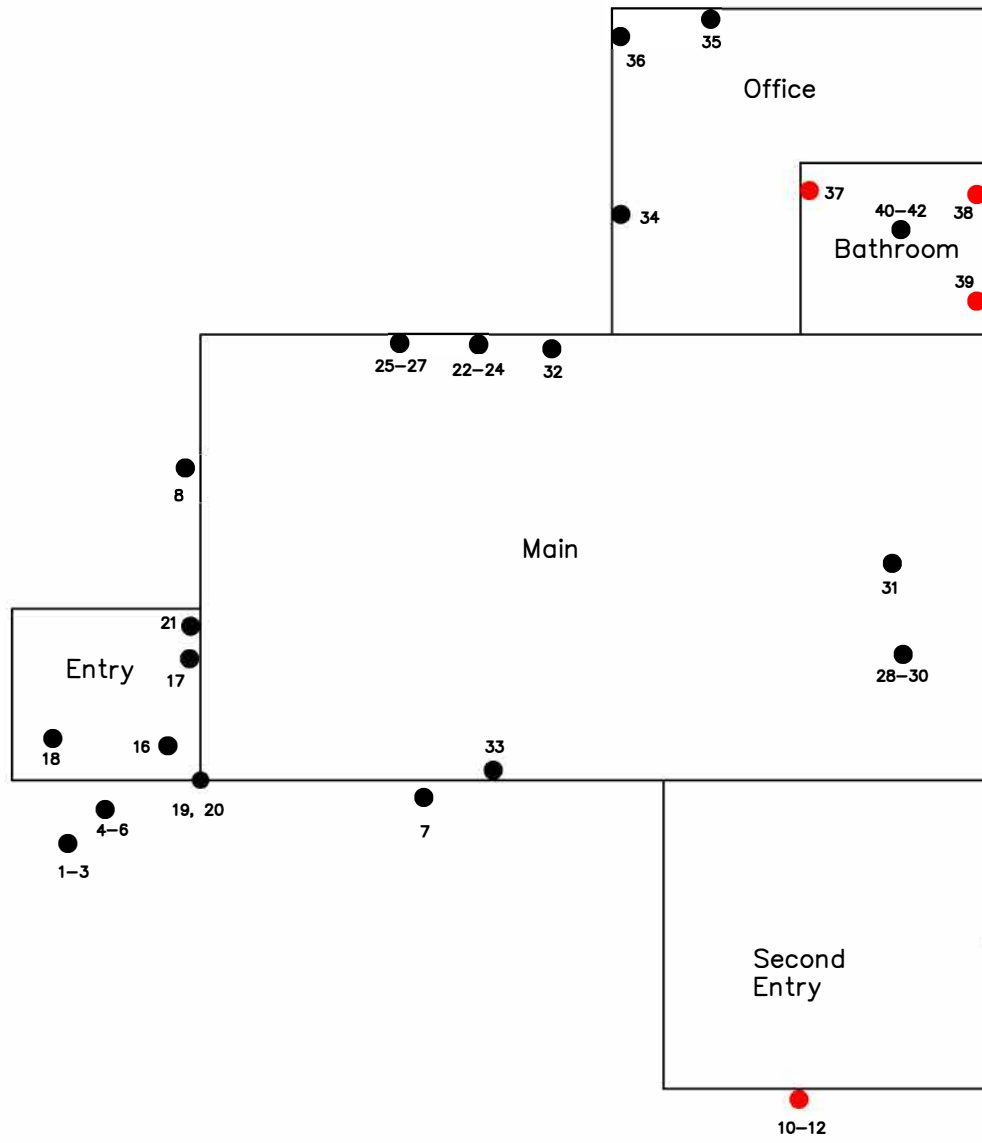
- ACM Sample Locations
- ACM Sample Location (>1% asbestos)

Notes:
ACM: Asbestos containing material
Sample locations are approximate
Scale 1' = 30'

Review of ACM data indicates that ACM at or above the regulatory standard of 1% asbestos was found in only two homogenous areas, the window with tan caulking along the south side of the building and beige wall texture and joint compound observed in the office bathroom. No other ACM was identified in the accessible areas of the interior or exterior of the building.

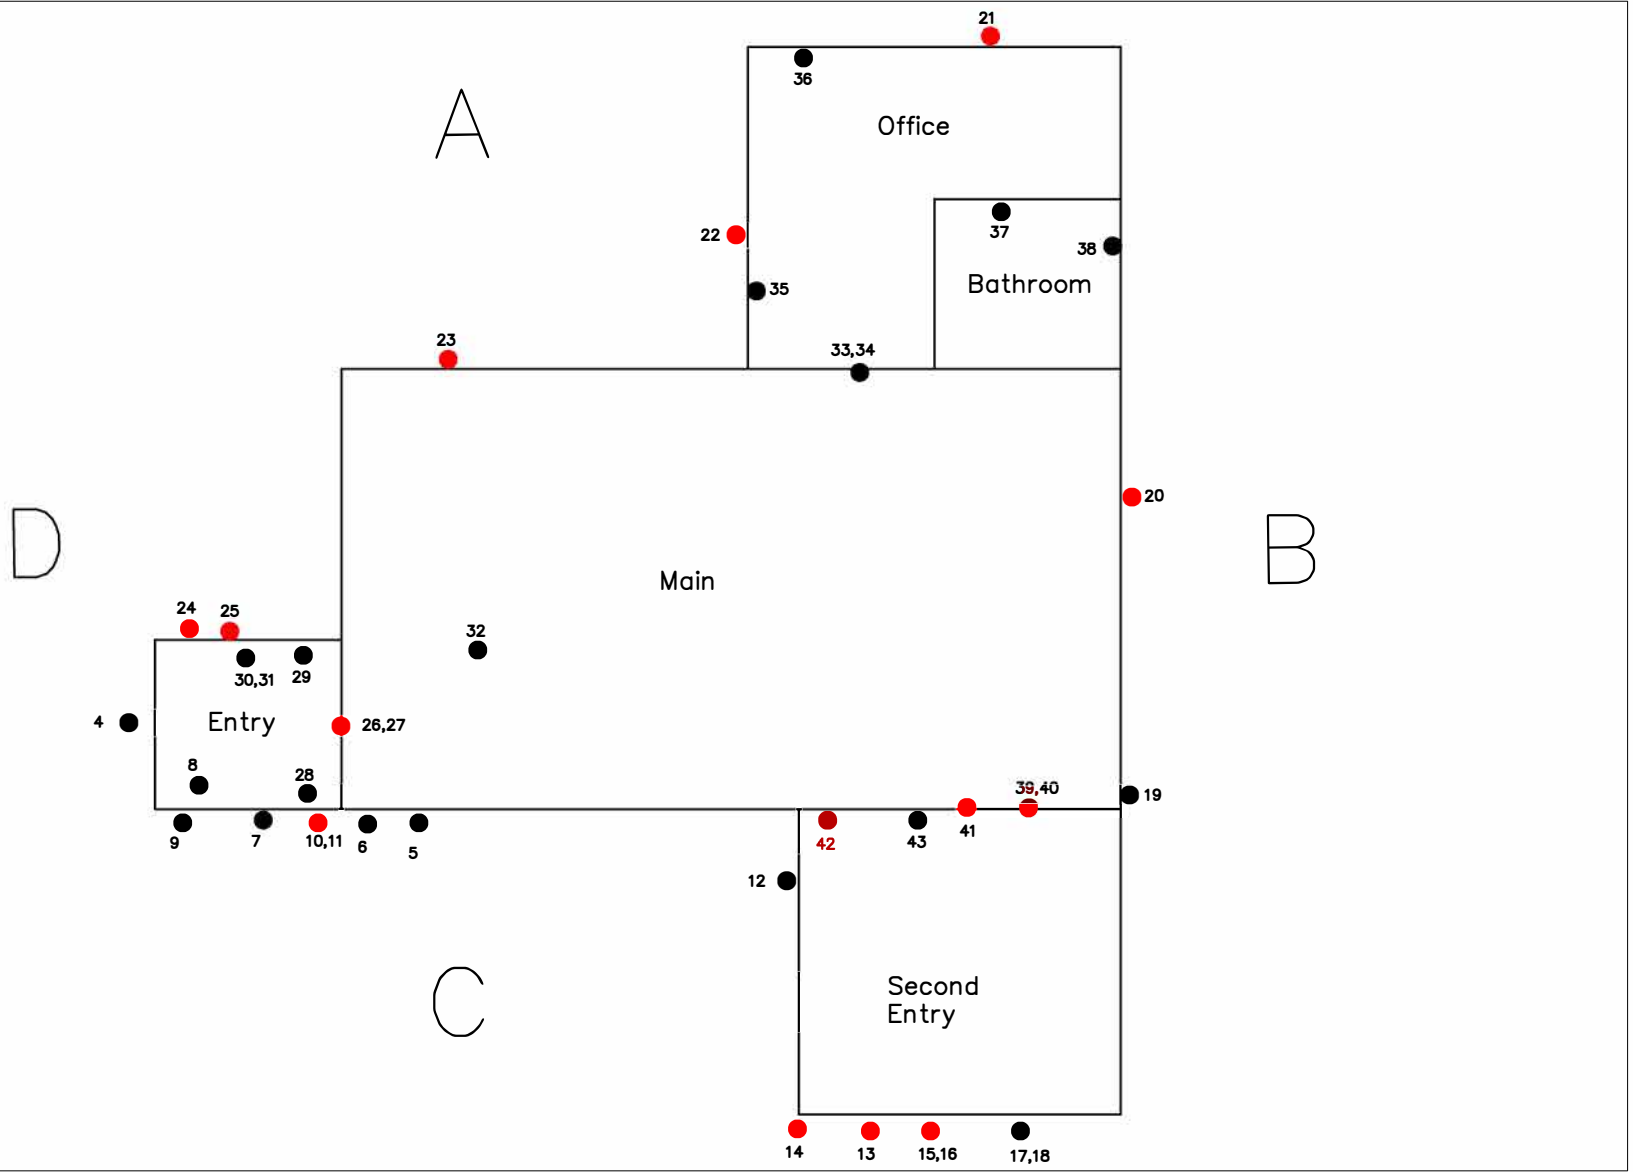
- Negative LBP Screen Locations (>1mg/cm²)
- Positive LBP Screen Locations (<1mg/cm²)

Notes:
 LBP: Lead-Based Paint
 Sample locations are approximate
 Scale 1' = 30'

START V conducted XRF calibration checks on the SciAps X-550 spectrometer according to the SciAps recommended protocol and HUD guidelines. These quality control readings were used to monitor the performance of the SciAps X-550 spectrometer. Calibration check readings were taken at the beginning and end of operation and every 4 hours during operation from a standard reference material (mounted on a wood block) that is provided with the SciAps X-550 XRF instrument. Section 3.1.2 summarizes the XRF screening results of painted surfaces at the subject property. Locations of LBP readings are depicted in Figure 5.

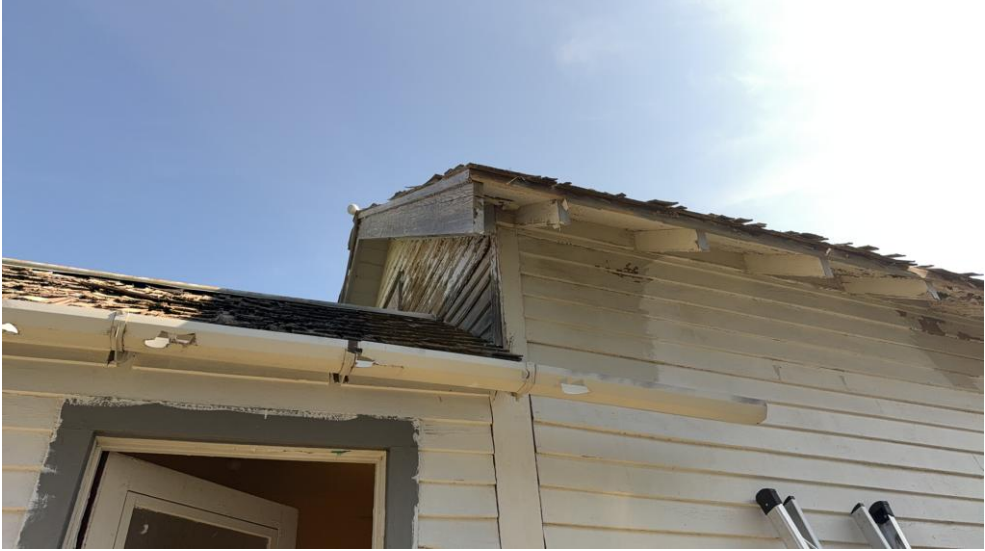
Photographer:	Kizer_Ryan	
Latitude:	47.003407	
Longitude:	-108.351491	
Photo Direction:	N	
Category:	<u>LBP Sample IDs:</u> 10- 2.73 mg/cm ² 11- 5.51 mg/cm ²	
Photo Description: Off-white siding and soffit

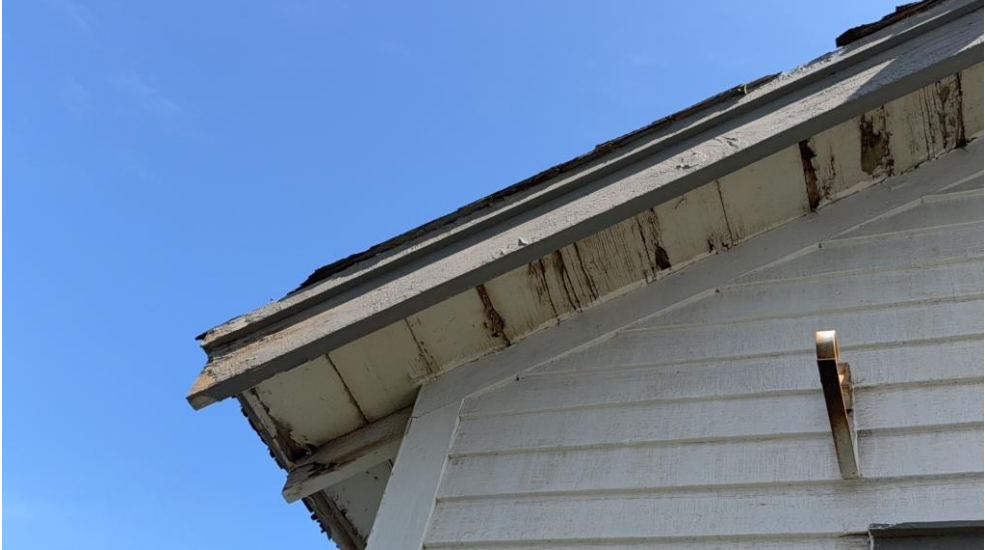
Photographer:	Kizer_Ryan	
Latitude:	47.003335	
Longitude:	-108.351423	
Photo Direction:	NNW	
Category:	<u>LBP Sample ID:</u> 14- 2.02 mg/cm ²	
Photo Description: Gray drip edge

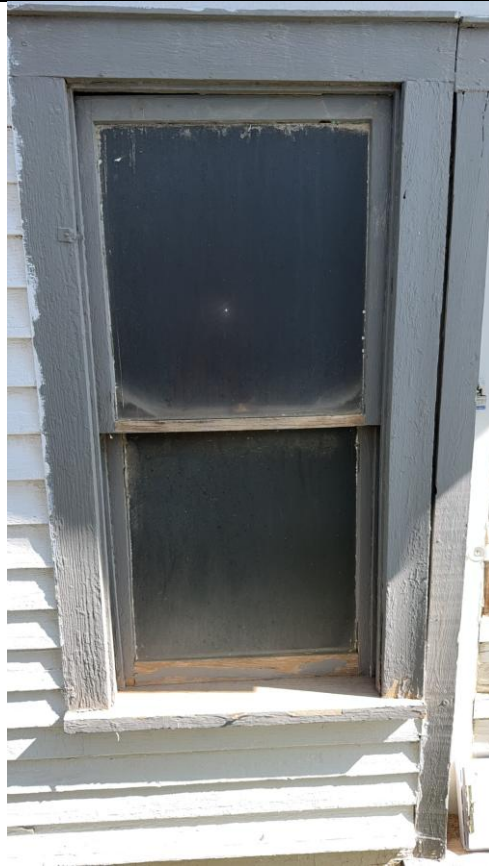
Date/Time Taken:	45825.40972222 222
Photographer:	Kizer_Ryan
Latitude:	47.003369
Longitude:	-108.351401
Photo Direction:	N
Category:	<u>LBP Sample IDs:</u> 16-4.71 mg/cm ² 15-1.44 mg/cm ²
Photo Description: Gray window and trim

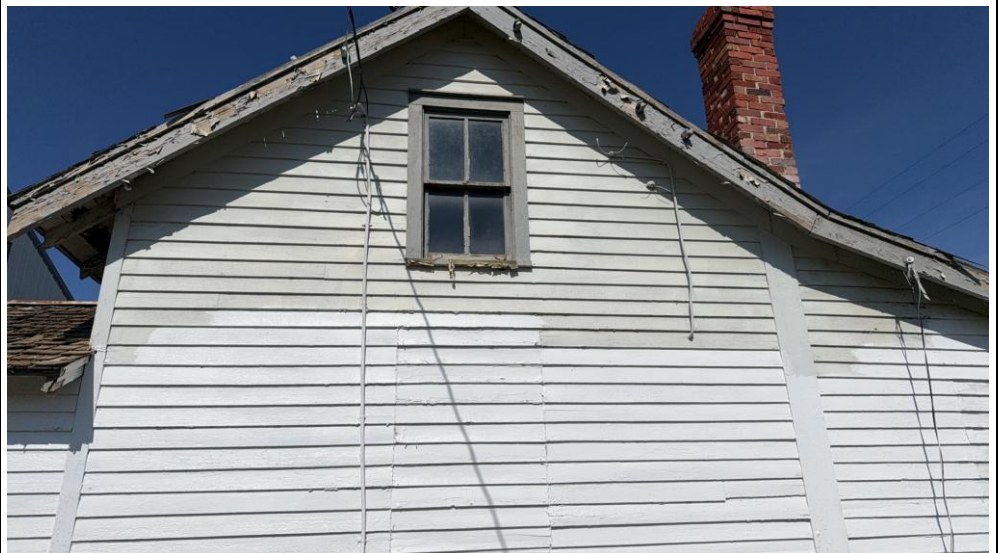
Date/Time Taken:	45825.41180555 556
Photographer:	Kizer_Ryan
Latitude:	47.003408
Longitude:	-108.351329
Photo Direction:	W
Category:	<u>LBP Sample ID:</u> 20-4.87 mg/cm ²
Photo Description: Off-white siding on east side

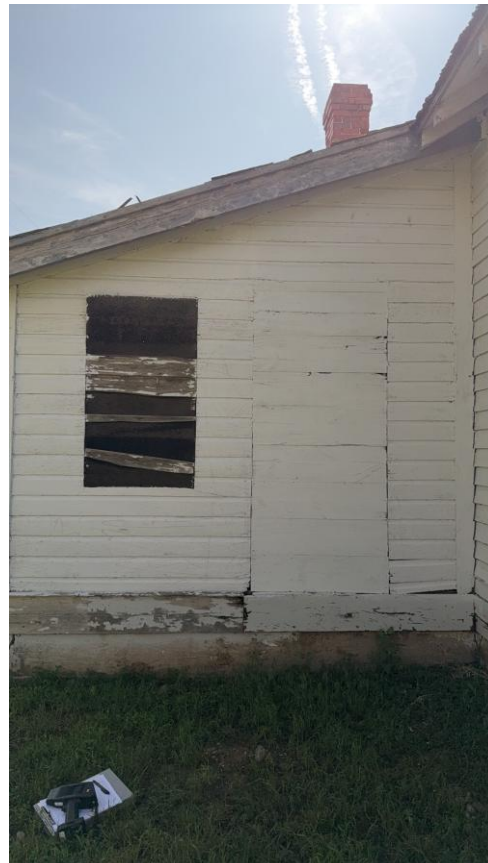
Date/Time Taken:	45825.41458333 333
Photographer:	Kizer_Ryan
Latitude:	47.003485
Longitude:	-108.351473
Photo Direction:	E
Category:	<u>LBP Sample ID:</u> 22-1.05 mg/cm²
Photo Description: White siding on east side	
Photo Name: Photos-20250617-155717.jpg

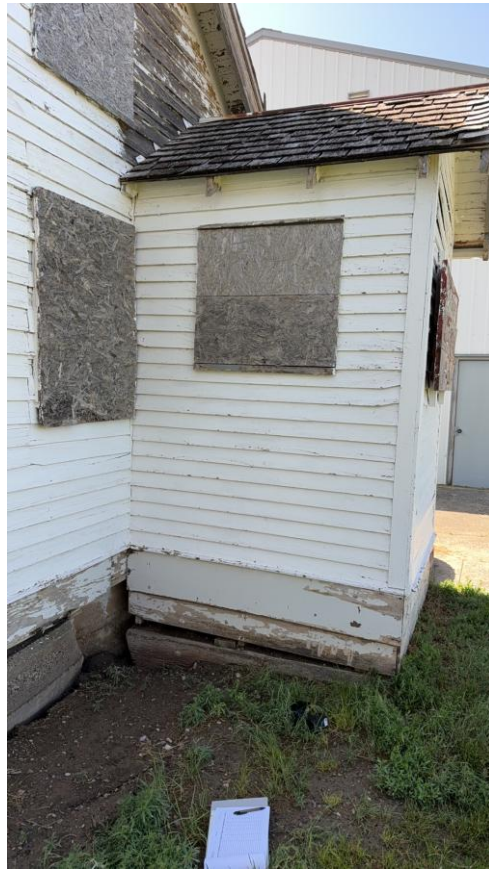
Date/Time Taken:	45825.41736111 111
Photographer:	Kizer_Ryan
Latitude:	47.003448
Longitude:	-108.351482
Photo Direction:	SSE
Category:	<u>LBP Sample ID:</u> 23-6.28 mg/cm²
Photo Description: North side siding6.	
Photo Name: Photos-20250617-160141.jpg

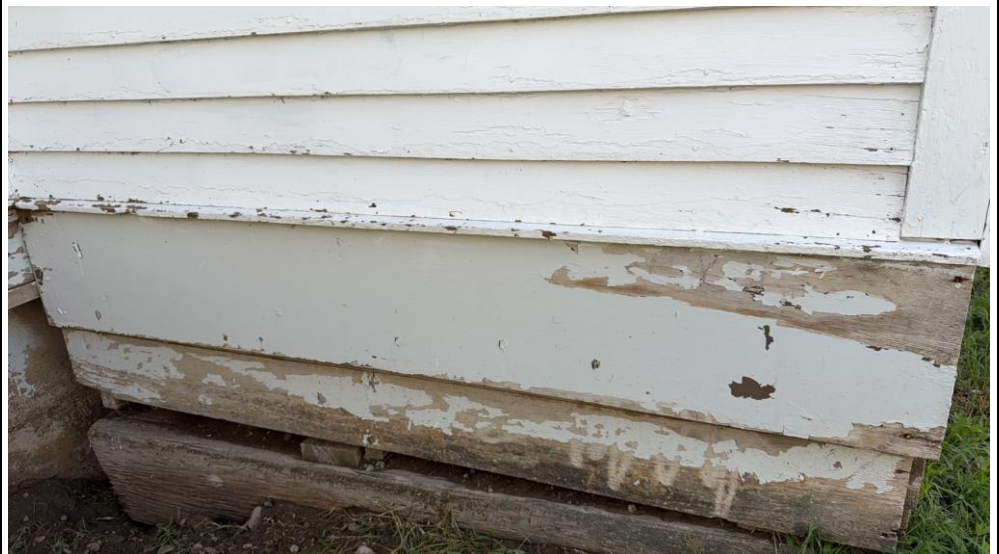
Date/Time Taken:	45825.41875
Photographer:	Kizer_Ryan
Latitude:	47.003457
Longitude:	-108.351501
Photo Direction:	SSE
Category:	<u>LBP Sample ID:</u> 25-1.79 mg/cm²
Photo Description: Brown paint under gray/green on siding trim	
Photo Name: Photos-20250617-160326.jpg

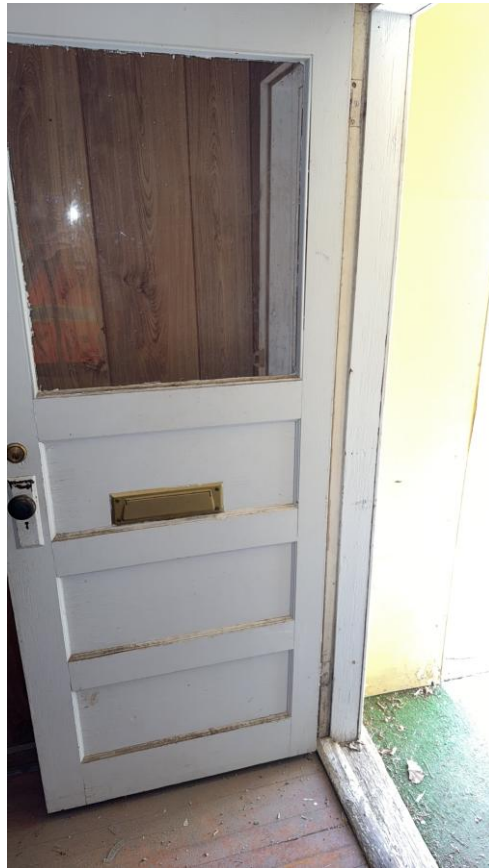
Date/Time Taken:	45825.425
Photographer:	Kizer_Ryan
Latitude:	47.003402
Longitude:	-108.351492
Photo Direction:	SE
Category:	<u>LBP Sample IDs:</u> 26-2.64 mg/cm ² 27-3.08 mg/cm ²
Photo Description: White door and door frame in entry	
Photo Name: Photos-20250617-161216.jpg

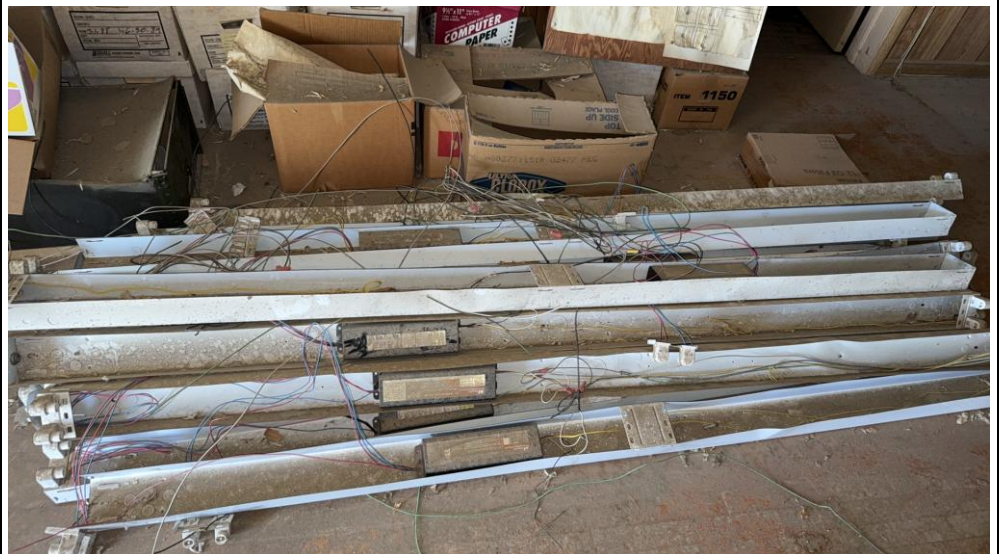
Date/Time Taken:	45825.42847222
Photographer:	Kizer_Ryan
Latitude:	47.003423
Longitude:	-108.351436
Photo Direction:	N
Category:	General Site Photos
Photo Description: Stack of light ballasts (no pcbs) on label	
Photo Name: Photos-20250617-161723.jpg

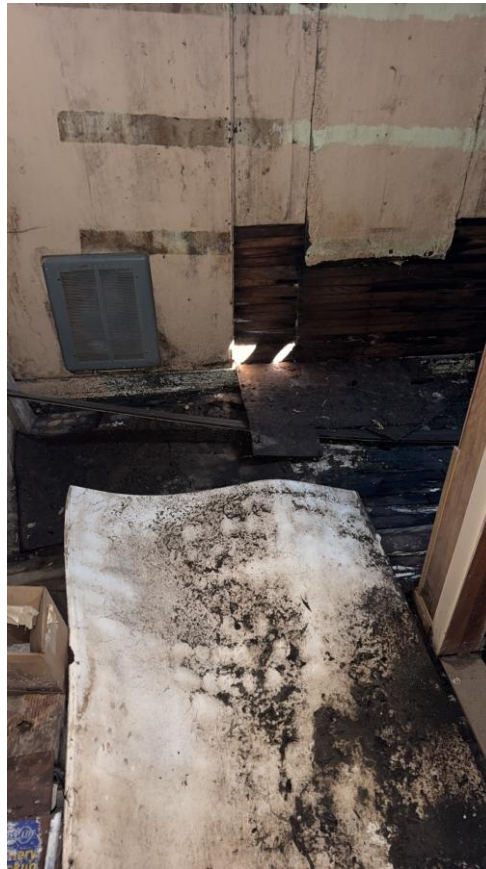
Date/Time Taken:	45825.43125
Photographer:	Kizer_Ryan
Latitude:	47.003435
Longitude:	-108.351409
Photo Direction:	N
Category:	General Site Photos
Photo Description:	Mold present in office
Photo Name:	Photos-20250617-162119.jpg

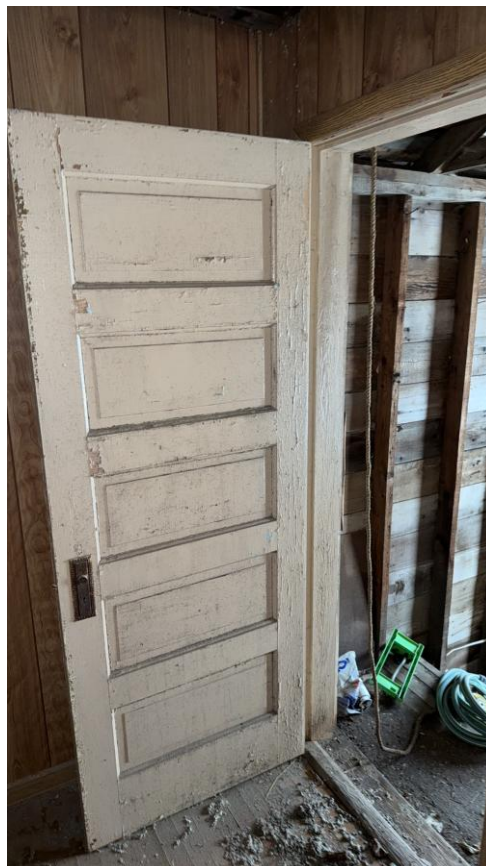
Date/Time Taken:	45825.43402777 778
Photographer:	Kizer_Ryan
Latitude:	47.003438
Longitude:	-108.351414
Photo Direction:	ESE
Category:	<u>LBP Sample IDs:</u> 39-2.92 mg/cm ² 40-1.92 mg/cm ²
Photo Description:	Door and door trim to 2nd entry
Photo Name:	Photos-20250617-162517.jpg

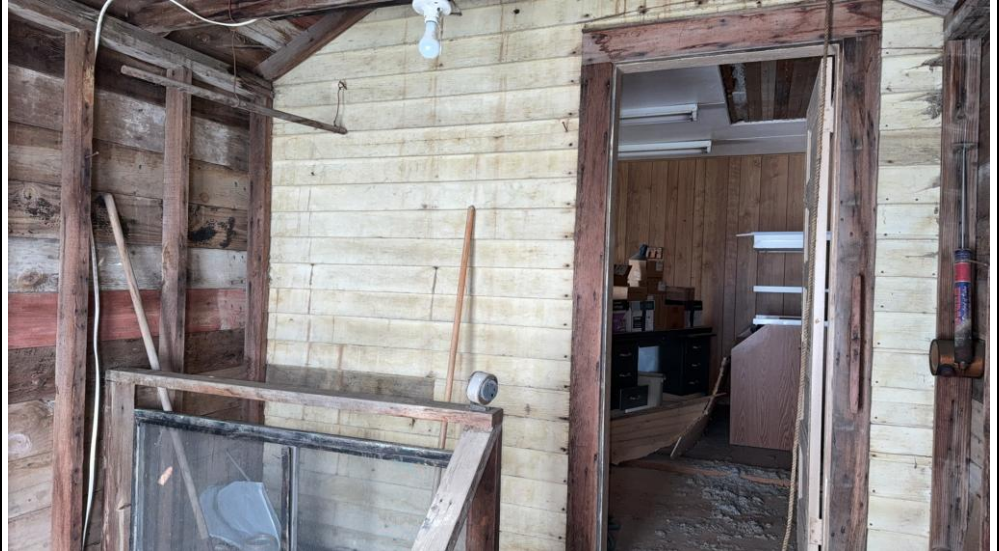
Date/Time Taken:	45825.43541666667
Photographer:	Kizer_Ryan
Latitude:	47.003401
Longitude:	-108.351401
Photo Direction:	NNW
Category:	<u>LBP Sample ID:</u> 41-6.82 mg/cm ²
Photo Description: Exposed siding on wall of second entry	
Photo Name: Photos-20250617-162708.jpg

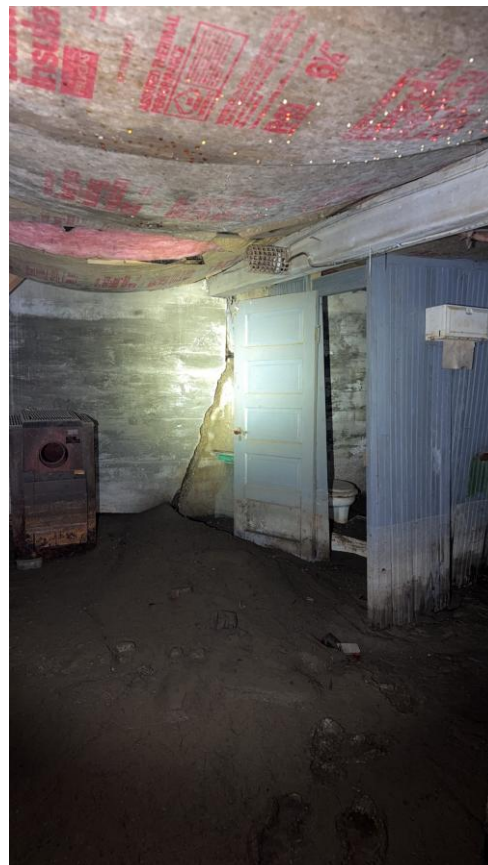
Date/Time Taken:	45825.44166666666
Photographer:	Kizer_Ryan
Latitude:	47.003391
Longitude:	-108.351418
Photo Direction:	W
Category:	<u>LBP Sample ID:</u> 44-1.03 mg/cm ²
Photo Description: Bathroom stall in basement	
Photo Name: Photos-20250617-163559.jpg

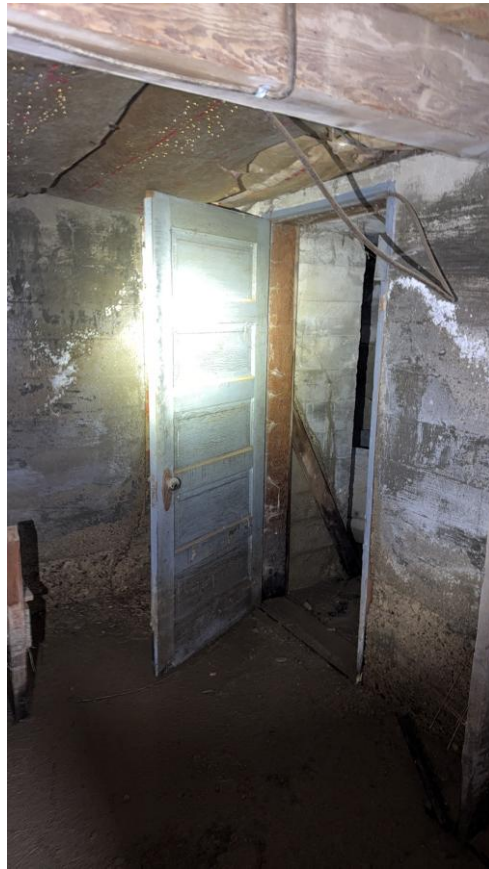
Date/Time Taken:	45825.44166666 6666
Photographer:	Kizer_Ryan
Latitude:	47.003257
Longitude:	-108.351454
Photo Direction:	NNE
Category:	<u>LBP Sample ID:</u> 45-1.60 mg/cm²
Photo Description: Door to coal room	
Photo Name: Photos-20250617-163630.jpg

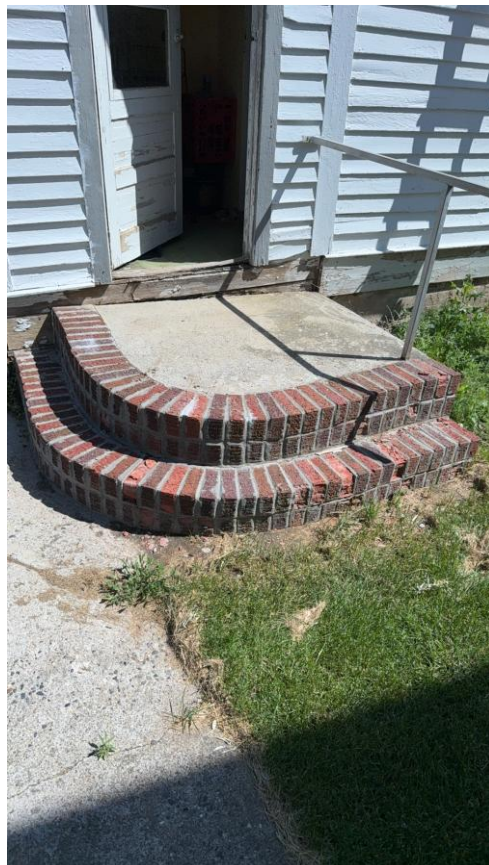
Date/Time Taken:	45825.45694444 444
Photographer:	Kizer_Ryan
Latitude:	47.003388
Longitude:	-108.351529
Photo Direction:	NNE
Category:	ACM Samp ID: WC-1-BM01-A-C WC-1-CON01-A-C
Photo Description: Brick and concrete on front steps	
Photo Name: Photos-20250617-165802.jpg

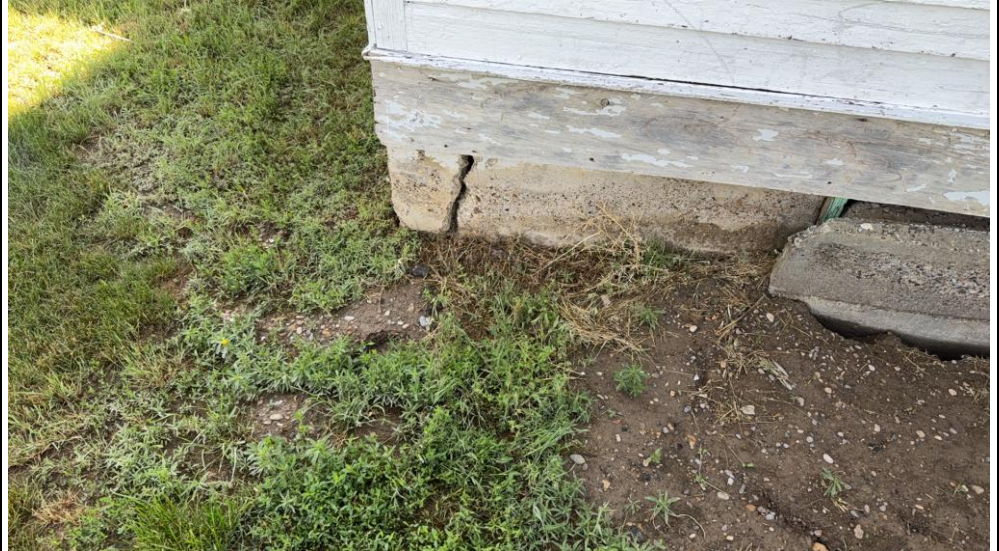
Date/Time Taken:	45825.45833333 3336
Photographer:	Kizer_Ryan
Latitude:	47.003436
Longitude:	-108.35151
Photo Direction:	ENE
Category:	ACM Samp ID: WC-1-CON02-A-C
Photo Description:	Concrete foundation
Photo Name:	Photos-20250617-170025.jpg

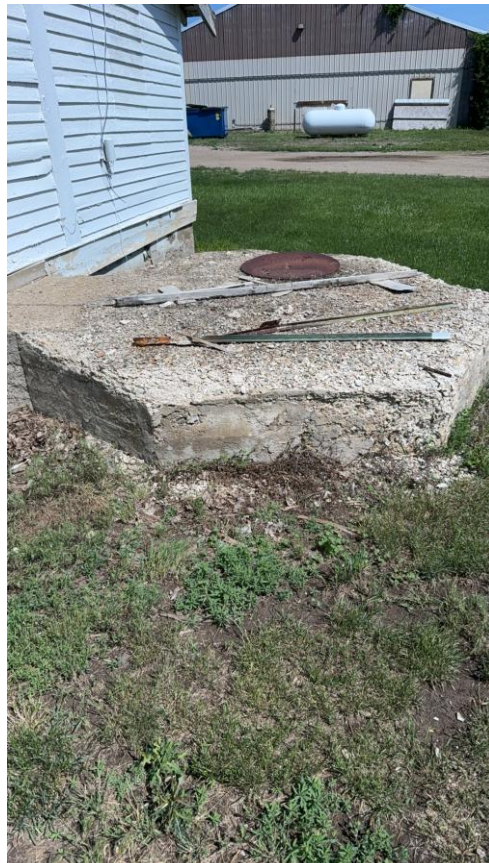
Date/Time Taken:	45825.46111111 111
Photographer:	Kizer_Ryan
Latitude:	47.003397
Longitude:	-108.351367
Photo Direction:	NNW
Category:	ACM Samp ID: WC-1-CON03-A-C
Photo Description:	Coal chute
Photo Name:	Photos-20250617-170429.jpg

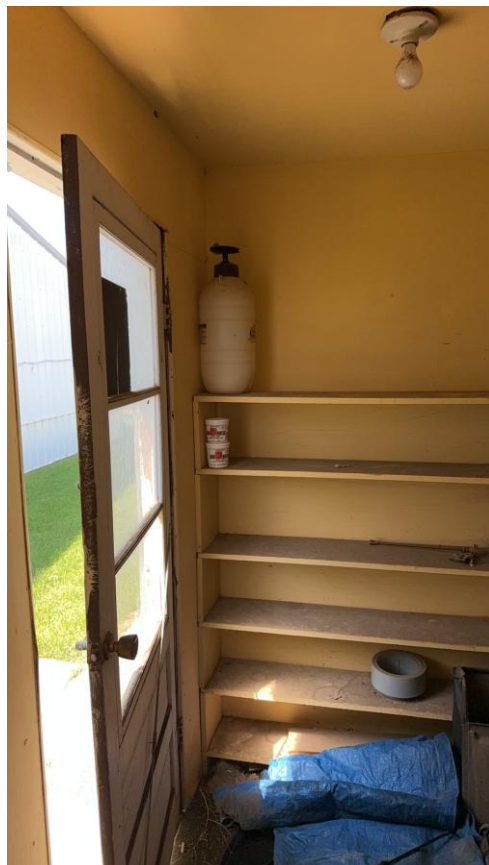
Date/Time Taken:	45825.46319444 444
Photographer:	Kizer_Ryan
Latitude:	47.003396
Longitude:	-108.351491
Photo Direction:	WSW
Category:	ACM Samp ID: WC-1- DWJC01-A-C
Photo Description: Drywall in entryway	
Photo Name: Photos-20250617-170754.jpg

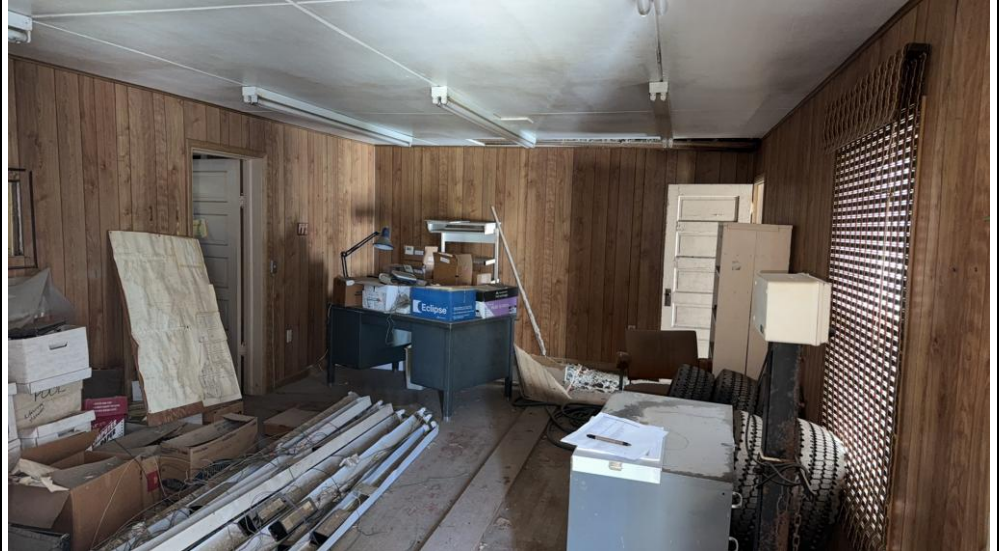
Date/Time Taken:	45825.46458333 3334
Photographer:	Kizer_Ryan
Latitude:	47.003422
Longitude:	-108.351478
Photo Direction:	E
Category:	ACM Samp ID: WC-1-WPL01-A-C
Photo Description:	Wood wall panel in main room
Photo Name:	Photos-20250617-170918.jpg

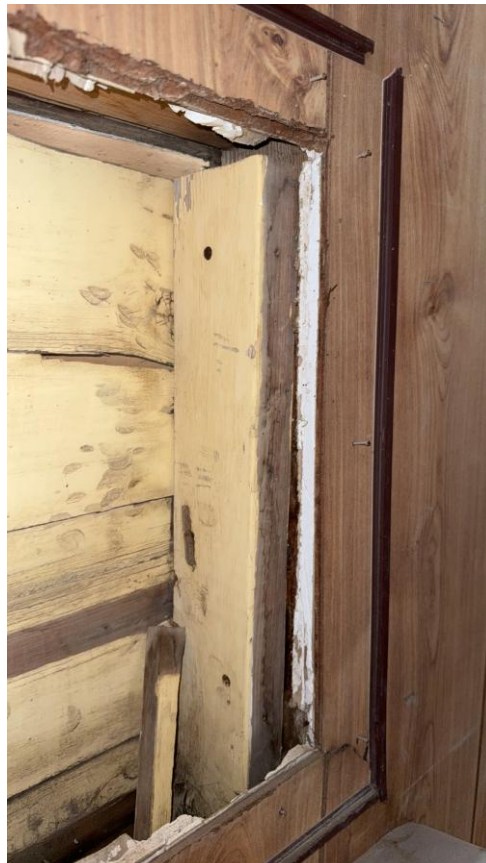
Date/Time Taken:	45825.46666666 667
Photographer:	Kizer_Ryan
Latitude:	47.003424
Longitude:	-108.351446
Photo Direction:	NNE
Category:	ACM Samp ID: WC-1-DW01-A-C
Photo Description:	Drywall under the wall panel
Photo Name:	Photos-20250617-171207.jpg

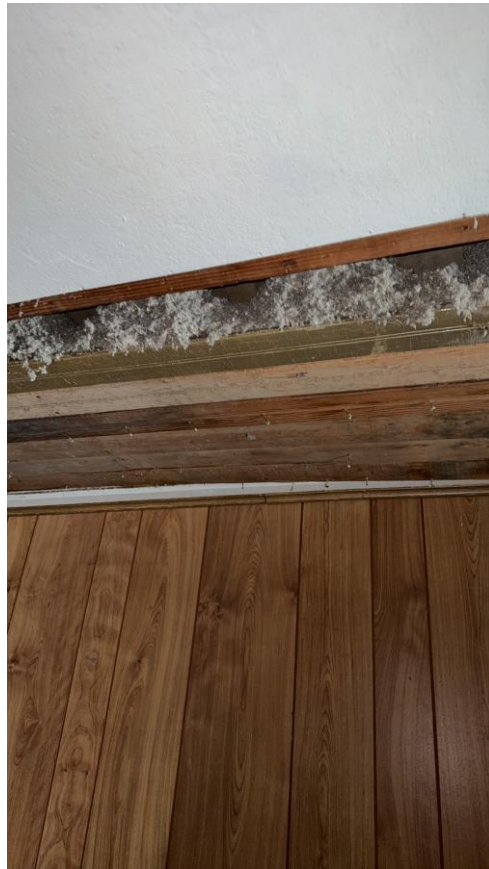
Date/Time Taken:	45825.46736111 1114
Photographer:	Kizer_Ryan
Latitude:	47.003428
Longitude:	-108.351458
Photo Direction:	NE
Category:	ACM Samp ID: WC-1-INS01-A-C
Photo Description: Blown in insulation in ceiling	
Photo Name: Photos-20250617-171320.jpg

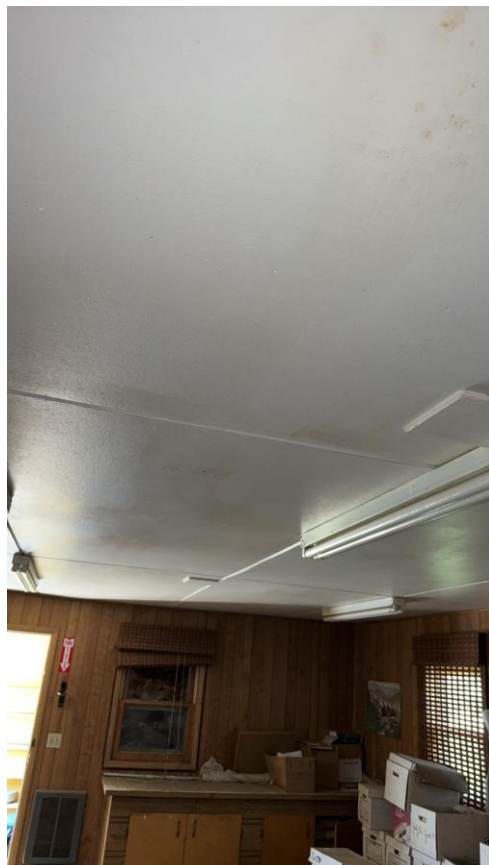
Date/Time Taken:	45825.46875
Photographer:	Kizer_Ryan
Latitude:	47.003417
Longitude:	-108.351428
Photo Direction:	W
Category:	ACM Samp ID: WC-1-PB01-A-C
Photo Description: Particle board on ceiling of main room	
Photo Name: Photos-20250617-171520.jpg

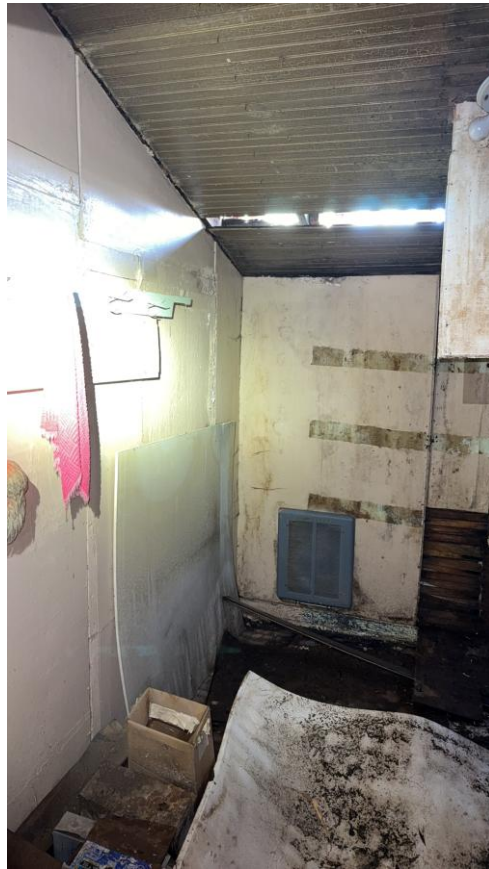
Date/Time Taken:	45825.47013888 8886
Photographer:	Kizer_Ryan
Latitude:	47.003434
Longitude:	-108.351432
Photo Direction:	NW
Category:	ACM Samp ID: WC-1-PB02-A-C
Photo Description:	Particle board in office
Photo Name:	Photos-20250617-171714.jpg

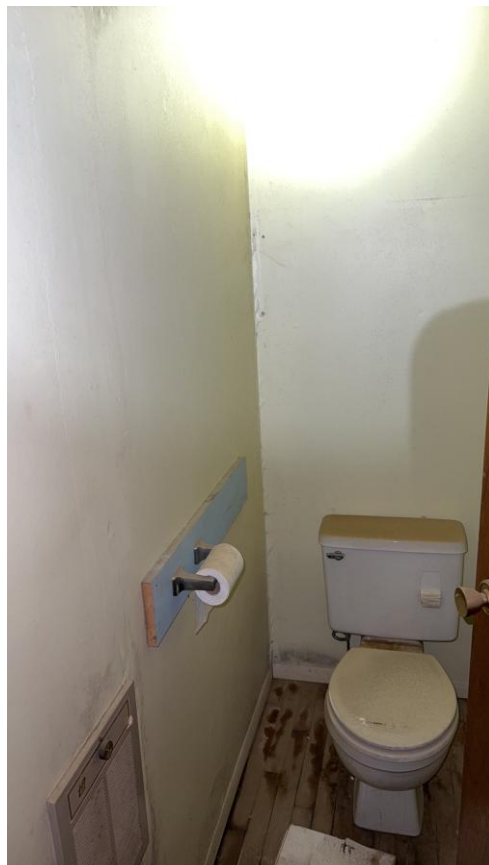
Date/Time Taken:	45825.47083333 333
Photographer:	Kizer_Ryan
Latitude:	47.003417
Longitude:	-108.35141
Photo Direction:	ENE
Category:	ACM Samp ID: WC-1- DWJC02-A-C
Photo Description:	Drywall in bathroom: Beige Texture (2% Chrysotile) Biege Joint Compound (2% Chrysotile)
Photo Name:	Photos-20250617-171814.jpg

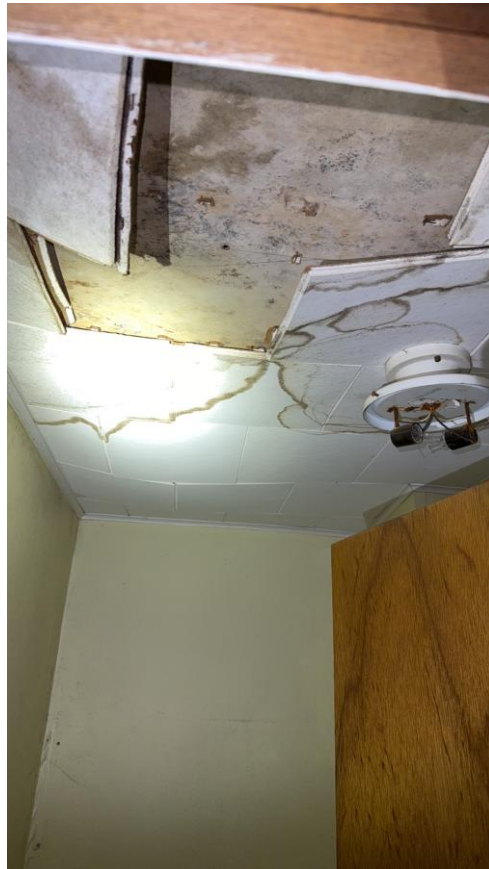
Date/Time Taken:	45825.47152777 778
Photographer:	Kizer_Ryan
Latitude:	47.003425
Longitude:	-108.351426
Photo Direction:	ENE
Category:	ACM Samp ID: WC-1-CT01-A-C
Photo Description: Ceiling tiles in bathroom	
Photo Name: Photos-20250617-171956.jpg

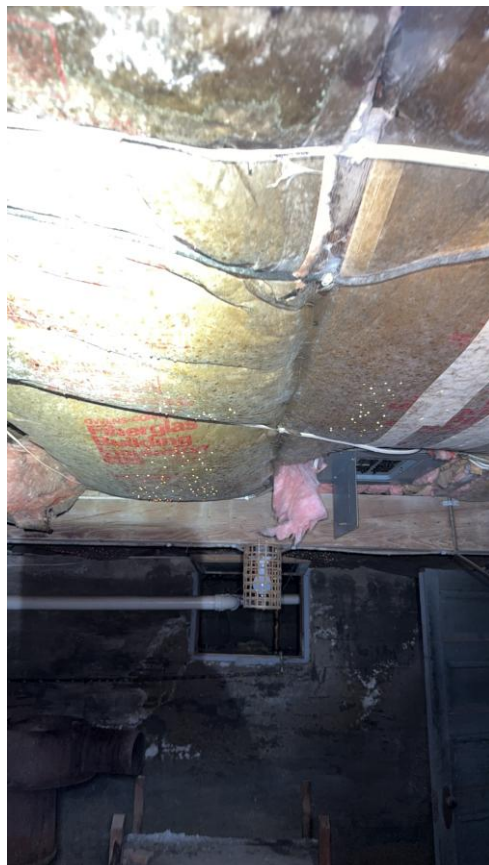
Date/Time Taken:	45825.53055555 555
Photographer:	Kizer_Ryan
Latitude:	47.003407
Longitude:	-108.351396
Photo Direction:	NNW
Category:	ACM Samp ID: WC-1-INS02-A-C
Photo Description: Backed insulation in basement ceiling	
Photo Name: Photos-20250617-184404.jpg

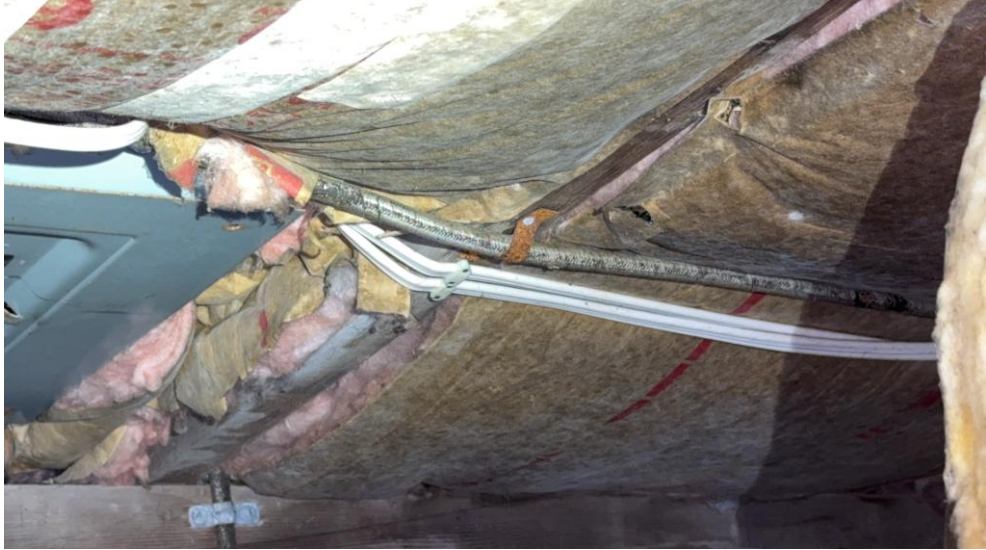
Photographer:	Kizer_Ryan	
Latitude:	47.003382	
Longitude:	-108.351279	
Photo Direction:	NNE	
Category:	ACM Samp ID: Not collected. Assumed hot	
Photo Description:	Electric wire insulation	
Photo Name:	Photos-20250617-184456.jpg
