# Phase II Environmental Site Assessment

## **SMDC The Backporch 101 Main Street Roundup, Montana**

Superfund Technical Assessment and Response Team (START) V Contract  
Contract No. 68HE0820D0001, Technical Direction No. 2360-2501-07

**August 28, 2025**

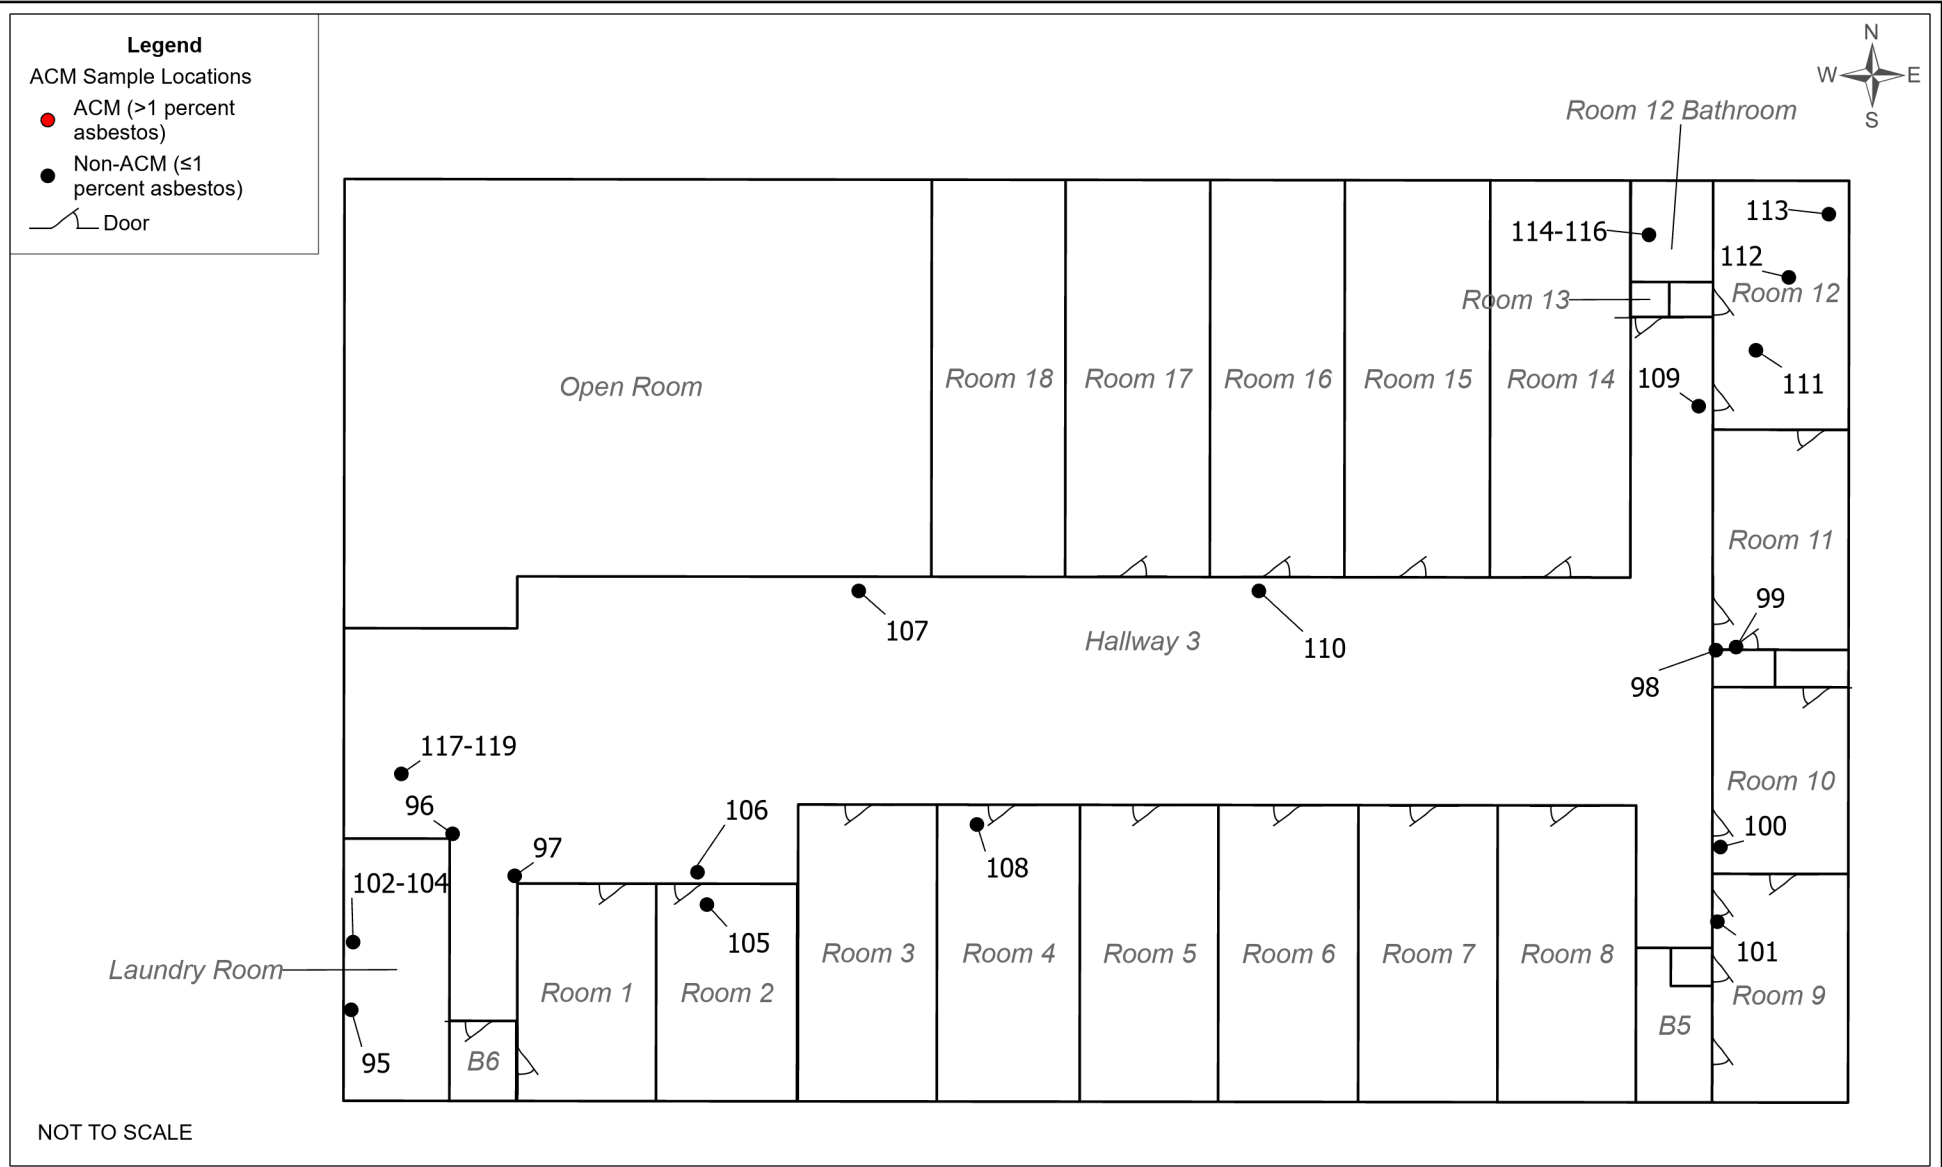
**Figure 5: ACM Sample Locations – Second Floor**

**Notes:**  
 ACM: Asbestos containing material  
 >: Greater than  
 ≤: Less than or equal to  
 SMDC: Snowy Mountain Development Corporation

START V identified ACM at the subject property, as identified in Table 1. Prior to performing any redevelopment or renovation activities of the subject property building, START V recommends the removal and disposal of the following identified ACM:

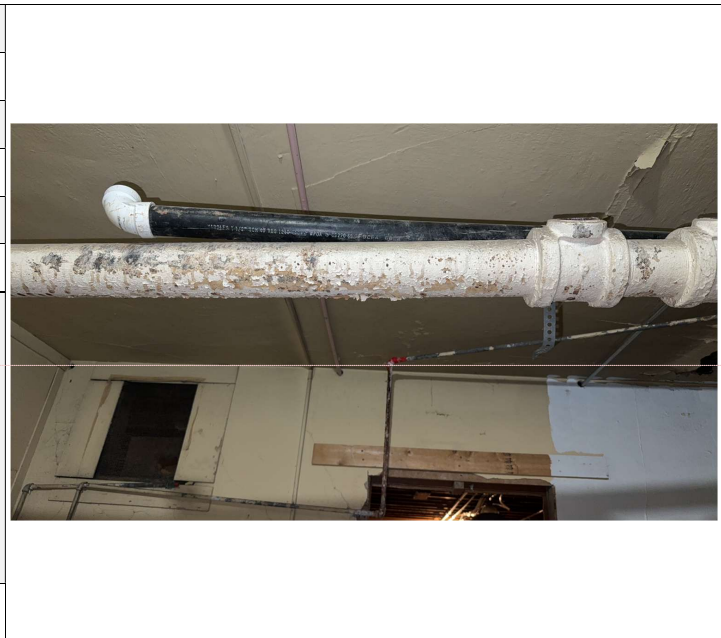
**Photo Description:**  
Suspect LBP was observed on a sanitary drainpipe in the basement.

Suspect LBP was observed throughout the interior and exterior of the subject property building. Prior to renovating the building, START V recommends that a comprehensive LBP survey be conducted to evaluate the presence of LBP at the subject property building.

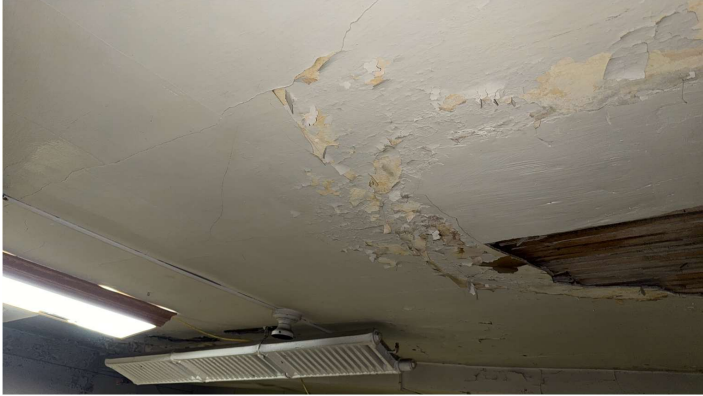
<b>Photographer:</b>	Kizer_Ryan	
<b>Latitude:</b>	46.442029	
<b>Longitude:</b>	-108.54205	
<b>Photo Direction:</b>	NW	
<b>Category:</b>	Suspect LBP	
<b>Photo Description:</b> Suspect LBP was observed on the ceiling in room 1 of the basement.		
<b>Photo Name:</b> Photos-20250709-170836.jpg

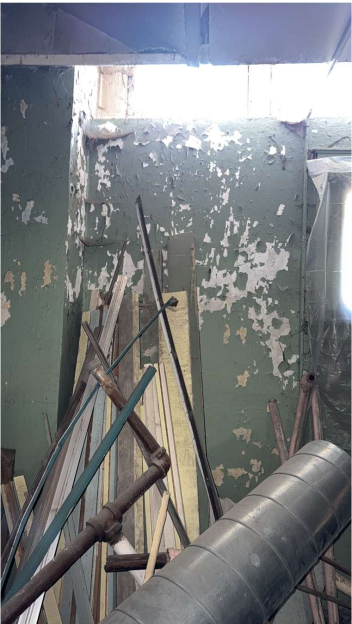
<b>Photographer:</b>	Kizer_Ryan	
<b>Latitude:</b>	46.441953	
<b>Longitude:</b>	-108.542093	
<b>Photo Direction:</b>	S	
<b>Category:</b>	Suspect LBP	
<b>Photo Description:</b> Suspect LBP was observed on the west wall of room 1 in the basement.		
<b>Photo Name:</b> Photos-20250709-170858.jpg

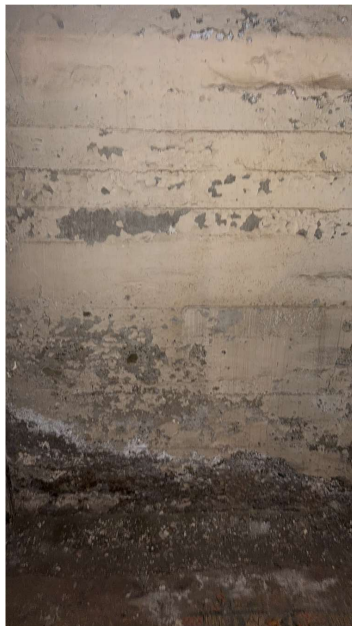
**Photo Description:**  
Suspect LBP was observed in hallway 1 of the basement.

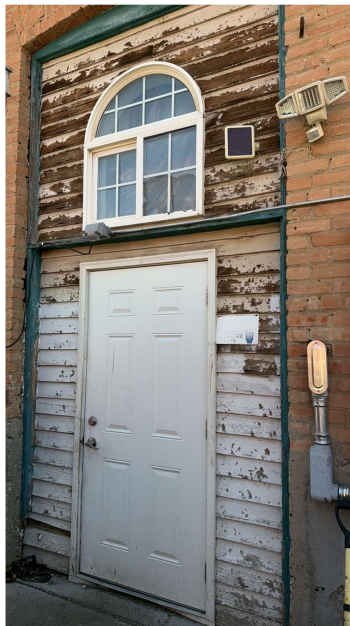
**Photo Description:**  
Suspect LBP was observed on the exterior doors and door frames of the building.

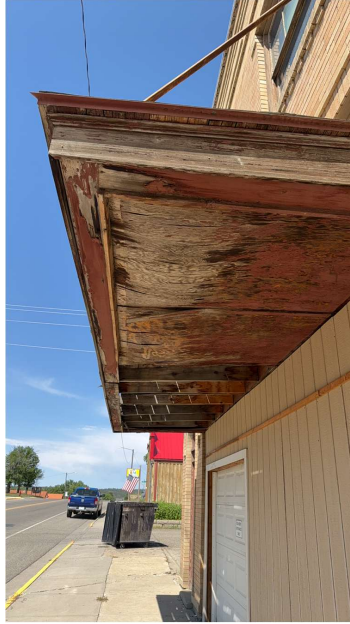
**Photo Description:**  
Suspect LBP was observed on the exterior siding of the building.

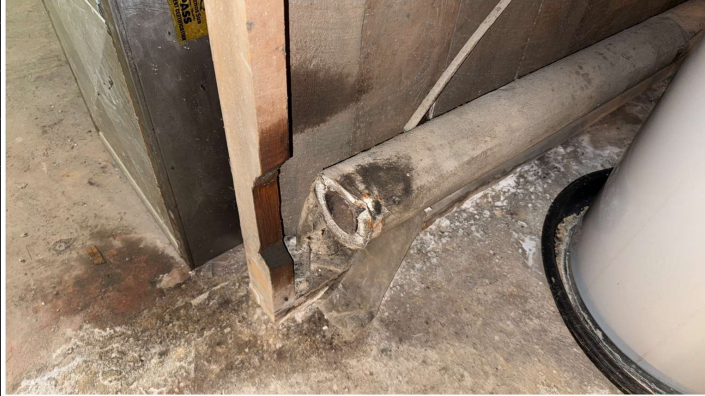
**Photo Description:**  
Off-white 6-inch pipe wrap (represented by samples TB-PW01-A, B, and C) in basement was identified as asbestos-containing material (ACM).

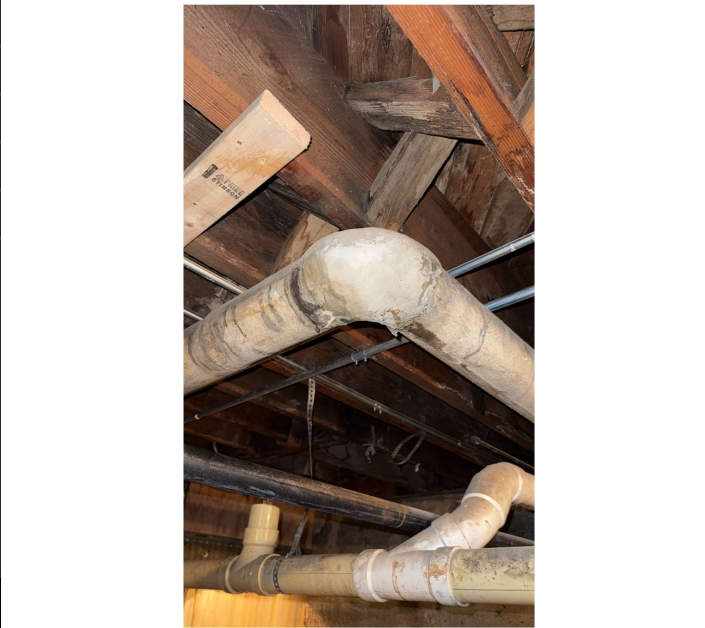
**Photo Description:**  
Off-white 6-inch pipe elbow (represented by samples TB-PE01-A, B, and C) in the main room of the basement was identified as ACM.

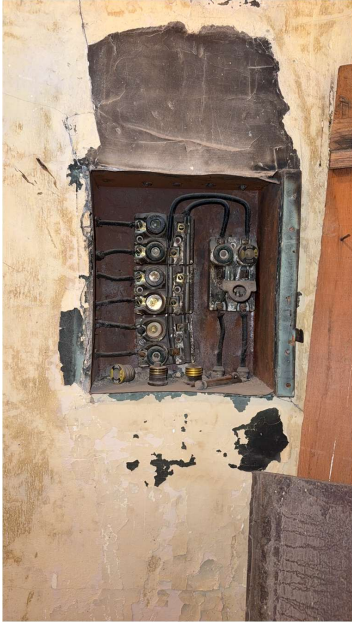
<b>Photographer:</b>	Kizer_Ryan	
<b>Latitude:</b>	46.441954	
<b>Longitude:</b>	-108.542538	
<b>Photo Direction:</b>	E	
<b>Category:</b>	Assumed ACM	
<b>Photo Description:</b> Old electrical wire insulation and transite insulation in this electrical panel on the second floor were not sampled and are assumed to be ACM.		
<b>Photo Name:</b> Photos-20250709-183146.jpg

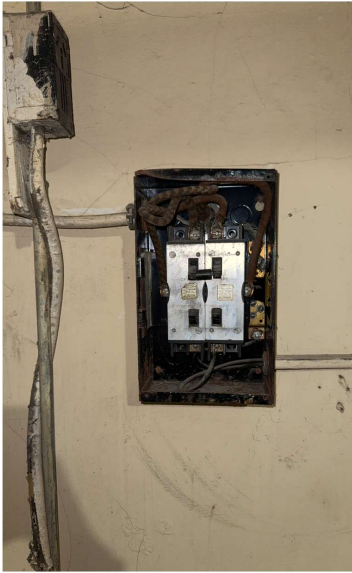
<b>Photographer:</b>	Kizer_Ryan	
<b>Latitude:</b>	46.442074	
<b>Longitude:</b>	-108.542268	
<b>Photo Direction:</b>	WSW	
<b>Category:</b>	Assumed ACM	
<b>Photo Description:</b> Electrical box and old wiring with assumed ACM in the basement utility room.		
<b>Photo Name:</b> Photos-20250709-183713.jpg

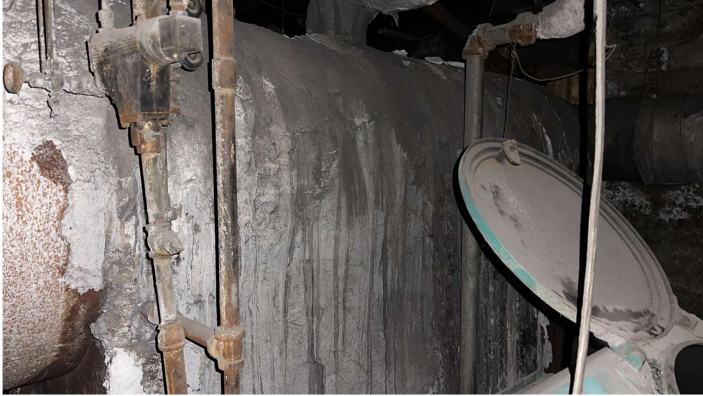
<b>Photographer:</b>	Tanko_Makena	
<b>Latitude:</b>	46.442014	
<b>Longitude:</b>	-108.542549	
<b>Photo Direction:</b>	SSW	
<b>Category:</b>	ACM	
<b>Photo Description:</b>	Gray boiler block insulation (represented by samples TB-BBI01-1-A, B, and C) in the basement boiler room was identified as ACM.	
<b>Photo Name:</b>	Photos-20250709-164517.jpg

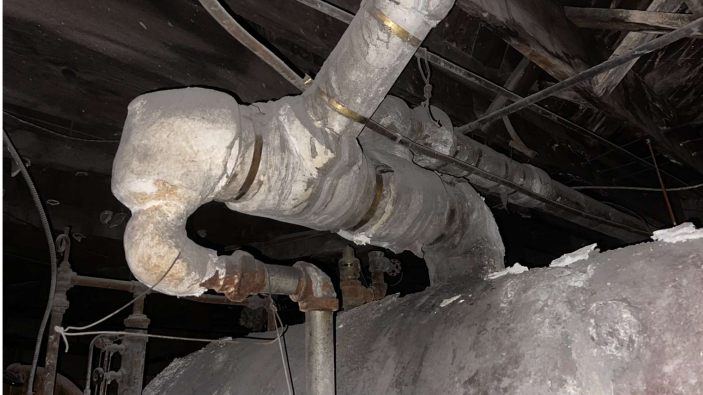
<b>Photographer:</b>	Tanko_Makena	
<b>Latitude:</b>	46.441923	
<b>Longitude:</b>	-108.542312	
<b>Photo Direction:</b>	SE	
<b>Category:</b>	ACM	
<b>Photo Description:</b>	Off-white 12-inch pipe insulation (represented by samples TB-PW02-01-A, B, and C) in the basement boiler room was identified as ACM.	
<b>Photo Name:</b>	Photos-20250709-170607.jpg

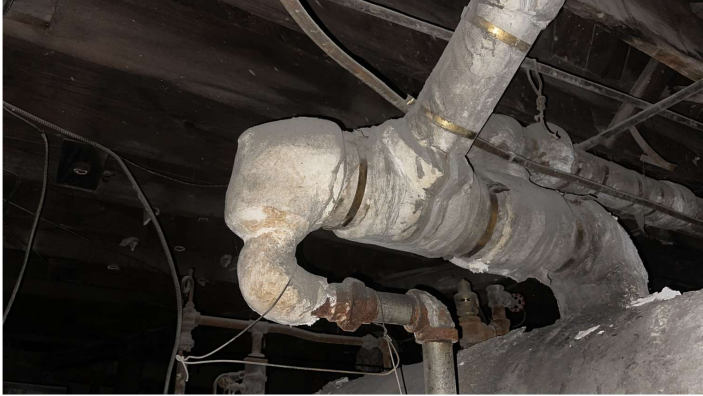
<b>Photographer:</b>	Tanko_Makena	
<b>Latitude:</b>	46.441923	
<b>Longitude:</b>	-108.542312	
<b>Photo Direction:</b>	ESE	
<b>Category:</b>	ACM	
<b>Photo Description:</b>	Off-white pipe elbow insulation (represented by samples TB-PE02-1-A, B, and C) in the basement boiler room was identified as ACM.	
<b>Photo Name:</b>	Photos-20250709-170700.jpg

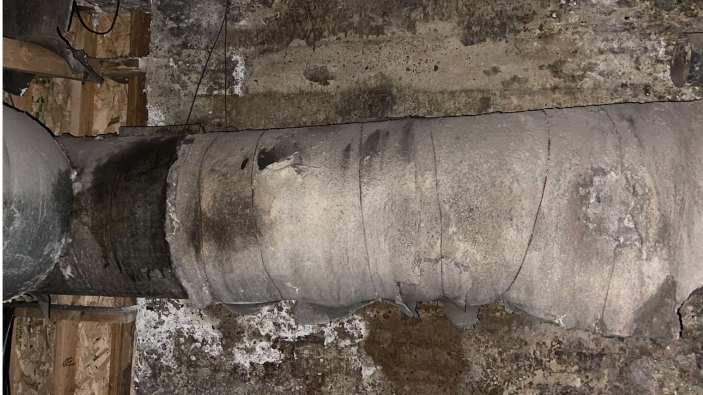
<b>Photographer:</b>	Tanko_Makena	
<b>Latitude:</b>	46.441978	
<b>Longitude:</b>	-108.542464	
<b>Photo Direction:</b>	WSW	
<b>Category:</b>	ACM	
<b>Photo Description:</b>	Off-white 24-inch pipe wrap insulation (represented by samples TB-PW03-1-A, B, and C) in boiler room was identified as ACM.	
<b>Photo Name:</b>	Photos-20250709-170738.jpg

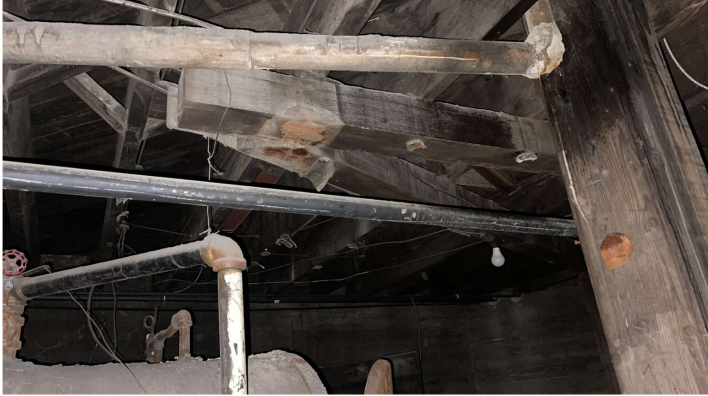
<b>Photographer:</b>	Tanko_Makena	
<b>Latitude:</b>	46.441955	
<b>Longitude:</b>	-108.542516	
<b>Photo Direction:</b>	NE	
<b>Category:</b>	ACM	
<b>Photo Description:</b>	Off-white 4-inch pipe wrap insulation (represented by samples TB-PW04-1-A, B, and C) in the basement boiler room was identified as ACM.	
<b>Photo Name:</b>	Photos-20250709-171647.jpg
