Draft Phase II Environmental Site Assessment

Homes on the Range 902 3rd Street East, Roundup, Montana

Superfund Technical Assessment and Response Team (START) V Contract
Contract No. 68HE0820D0001, Technical Direction No. 2360-2311-03
Document Tracking Number (DTN): 1464

February 29, 2024

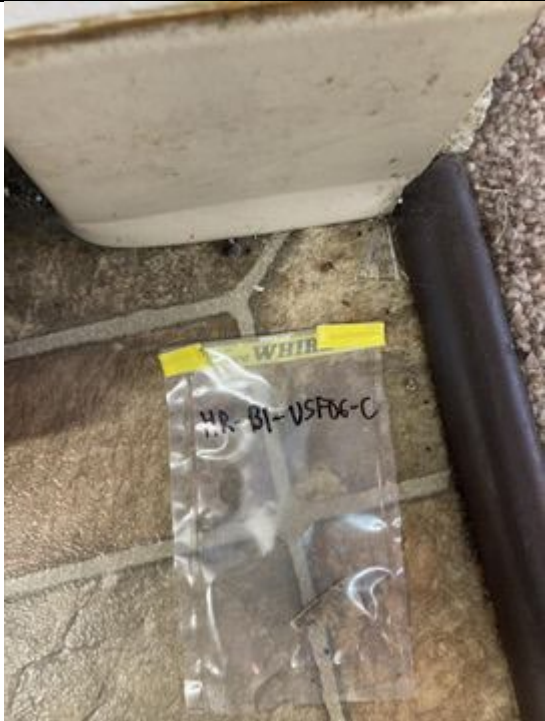
| Location: Building 1. | | | |

| Description: HR-B1-VSF06-C Black mastic contains 6% chrysotile. | | | |

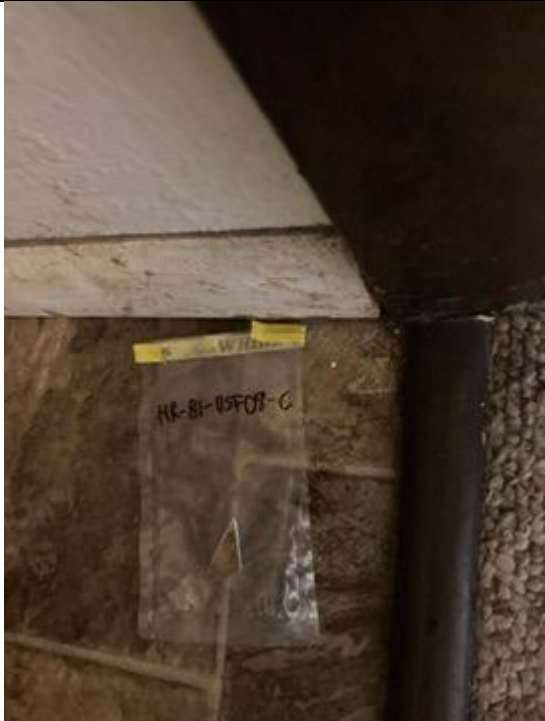
| Description: HR-B1-VSF08-C | | | | |

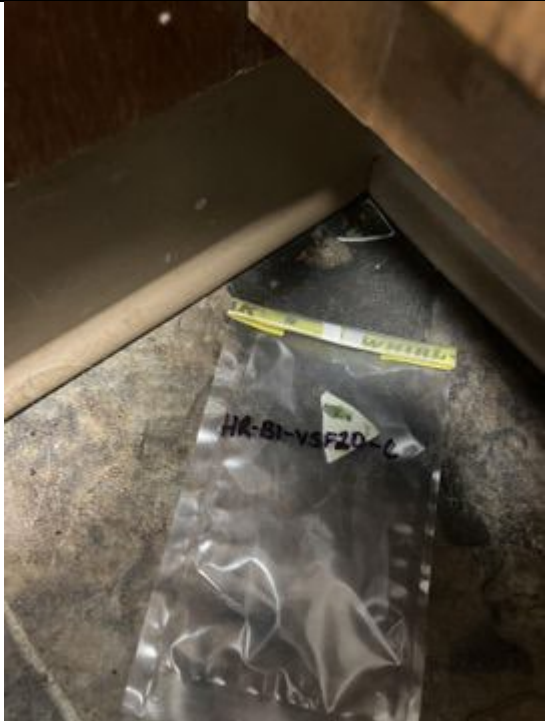
| Description: HR-B1-VSF10-C | | | | |

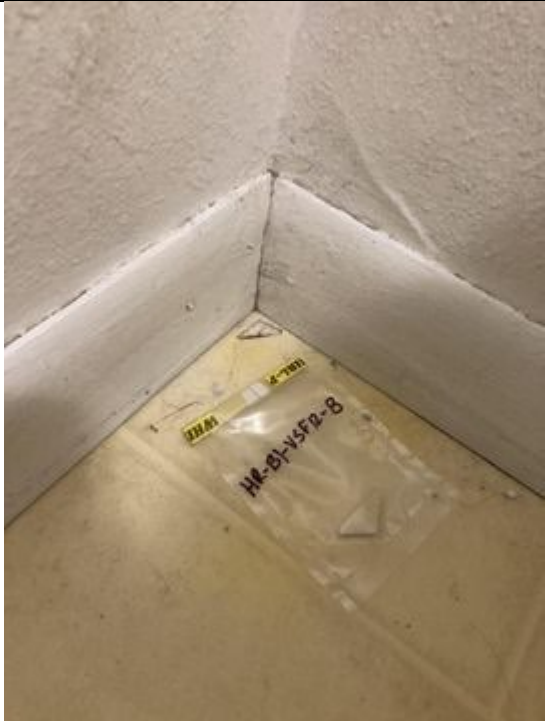
| Description: HR-B1-VSF12-B | | | | |

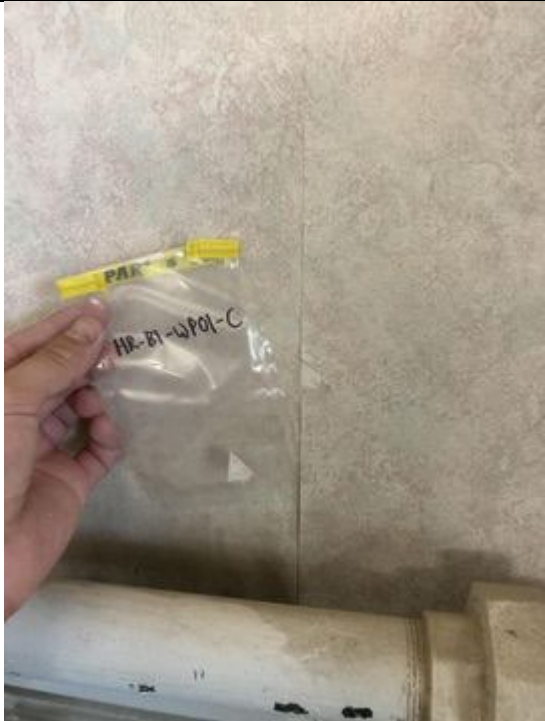
| Description: HR-B1-WP01-C | | | | |

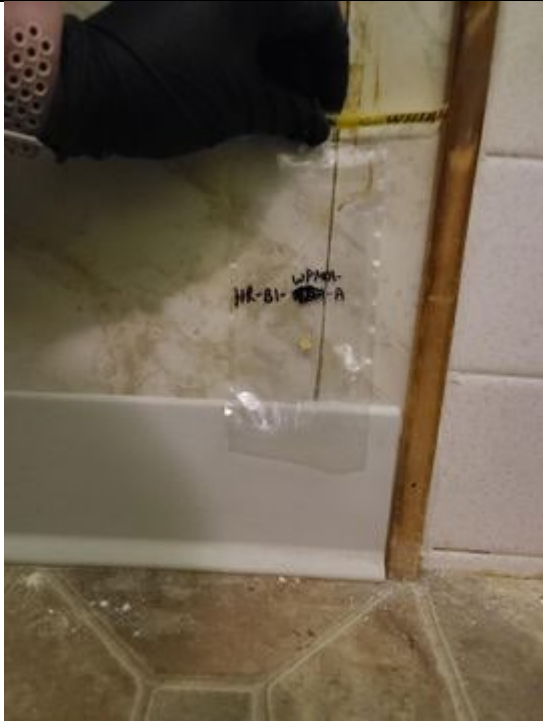
| Description: HR-B1-WPM01-A | | | |

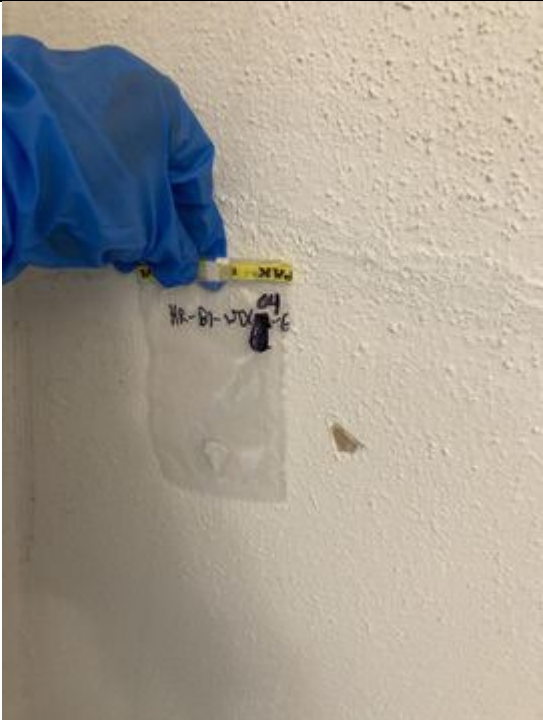
| Description: HR-B1-WTX04-G Beige texture contains 2% chrysotile. | | |

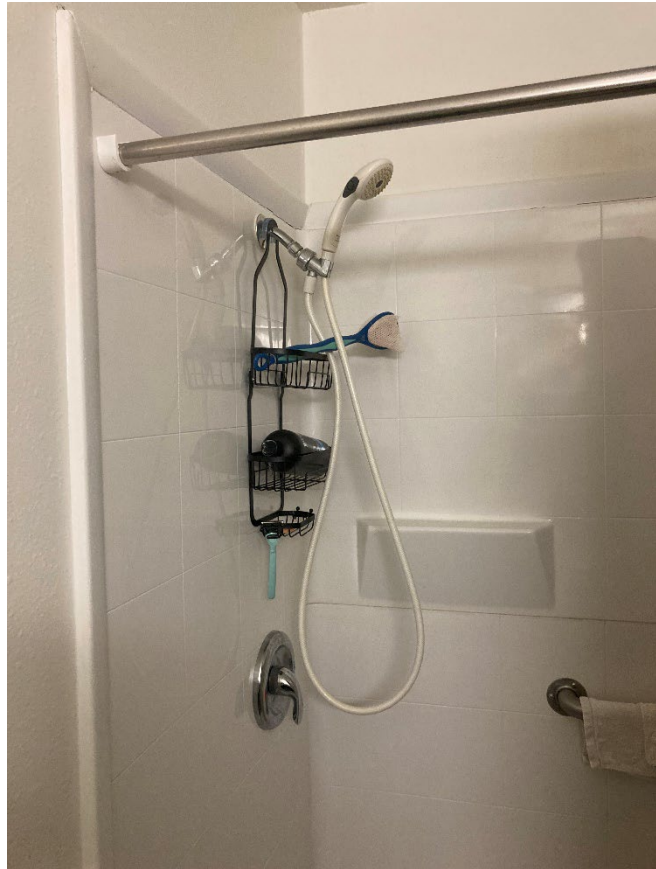
| Description: | Fiberglass reinforced panel shower insert; not sampled due to damage risk; Unit A6. |

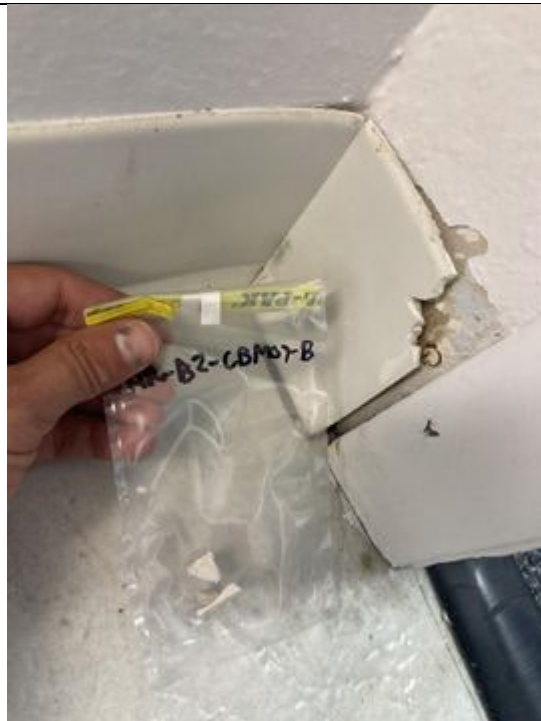
| Description: | HR-B2-CBM01-B White compound material contains 2% chrysotile. |

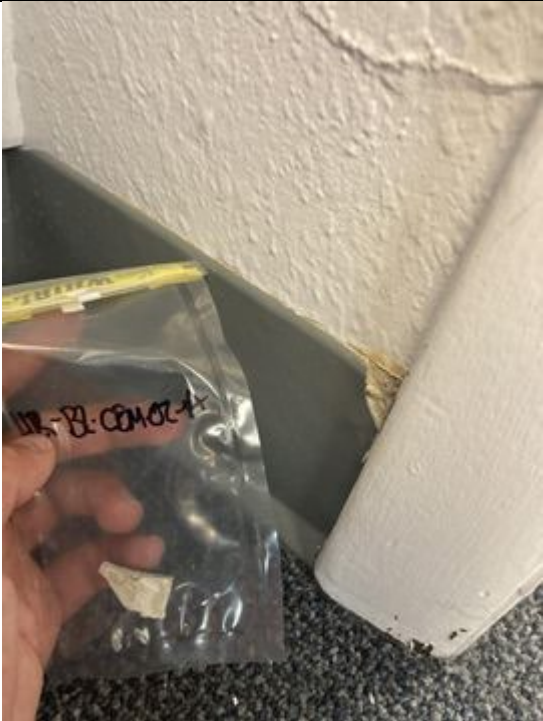
| Description: HR-B2-CBM02-A White compound material contains 2% chrysotile. | | |

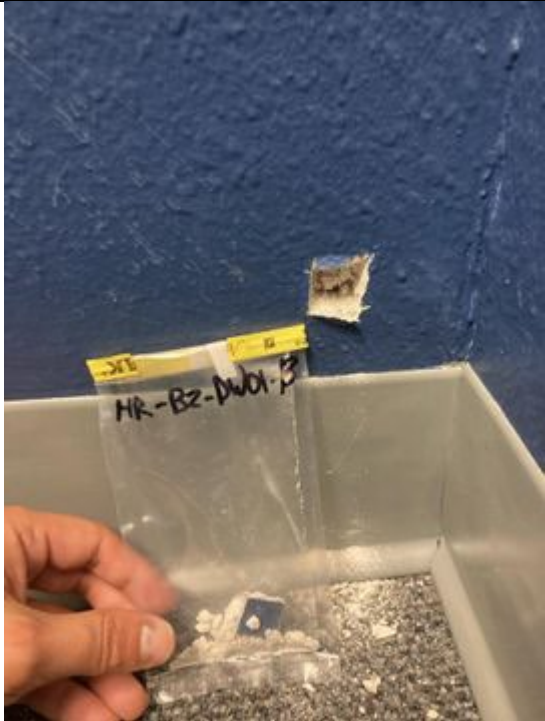
| Description: HR-B2-DW01-B Off-white joint compound contains 2% chrysotile. | | | | |

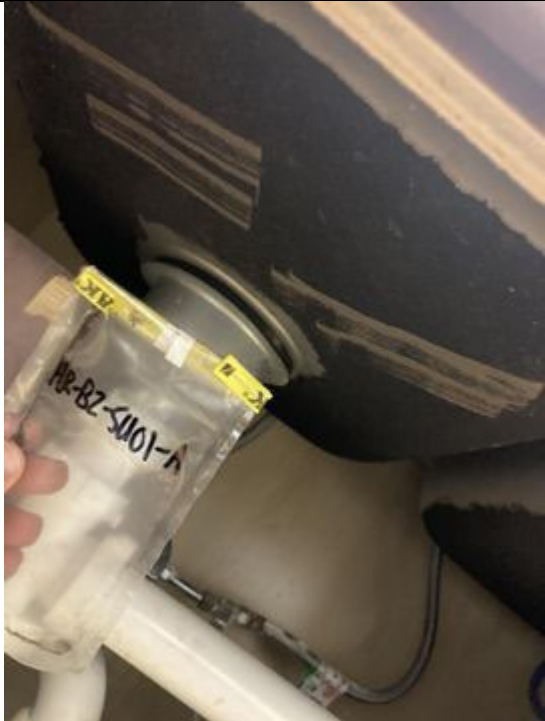
| Description: HR-B2-SU01-A Black undercoat contains 2% chrysotile. | | | | |
